## General Information

| Make | Toyota | Model | Vios |
| YOM | 2024 | Mileage | 18,370 |
| Registration No. | NHM8539 | Chassis No. | PA1B18F35R4244100 |

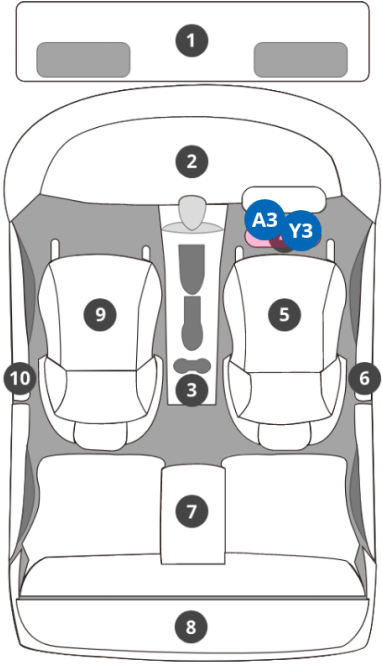
| Interior Evaluation : <b>B</b> | Exterior Evaluation : <b>B</b> |
|---|---|
| <b>Remarks</b><br>(R) Front Floor Mat - Grime - Medium / (L) Front Floor Mat - Cut, Crack - Medium | <b>Remarks</b><br>Front Bumper, Grille, Lamps - Scratch - Medium / Rear Bumper, Lamps, Panels - Scratch - Small |
