## General Information

| Make | Toyota | Model | Vios |
| Registration No. | DAQ8671 | Chassis No. | PA1B18F36N4179381 |

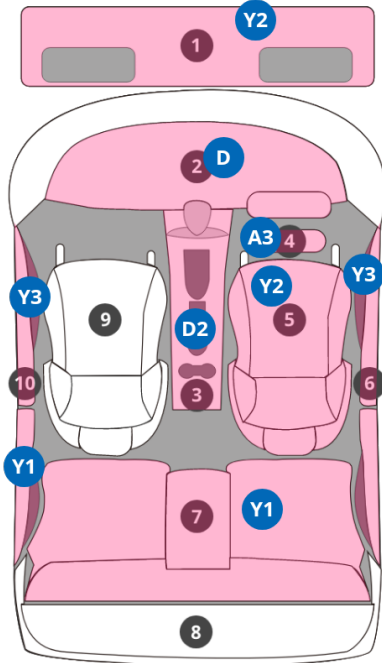
| <b>Interior Evaluation :</b> <span style="color: red; font-weight: bold;">C</span> | <b>Exterior Evaluation :</b> <span style="color: red; font-weight: bold;">C</span> |
| <b>Remarks</b><br>Dashboard - Traces of Adhesive Tape - Yes / Carpet - Worn, Scratch, Cut, Crack - Medium / (L) Front Trim - Grime - Medium / Ceiling - Grime - Small / (R) Front Seat - Grime - Small / (R) Front Trim - Grime - Medium / Console, Switches, Vents - Loose, Deformed - Small / Rear Seat - Grime - Minimal / (L) Rear Trim - Grime - Minimal | <b>Remarks</b><br>(R) Rear Fender - Repair Traces - Yes / (R) Rear Door - Repair Traces - Yes / (R) Front Fender, Molding - Scratch - Minimal / (R) Front Door, Molding - Scratch - Medium / (R) Step, In-panel, Side Spoiler - Scratch - Small / (R) Rear Door, Molding - Scratch - Minimal / Rear Bumper, Lamps, Panels - Scratch & Dent - Small / Trunk Hood, Rear Gate - Scratch - Small / (L) Front Door, Molding - Scratch - Small / Roof - Scratch - Small / Front Bumper, Grille, Lamps - Scratch - Large / Bonnet, Headlight - Scratch - Minimal / (L) Mirror - Scratch - Small |
