## General Information

| Make | Toyota | Model | Lite Ace |
| Registration No. | DBM6449 | Chassis No. | MHKU3FE10PK006262 |

## Body / Panel Condition

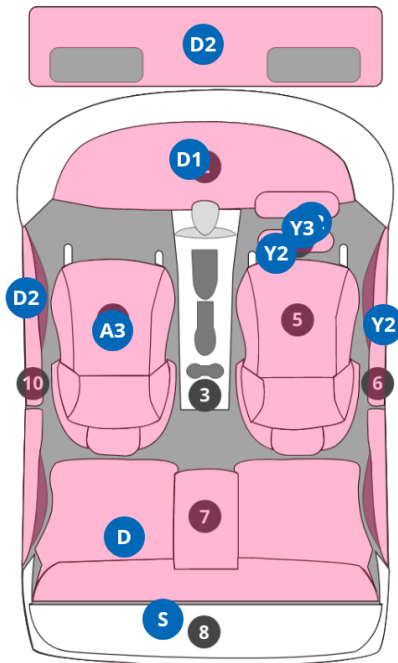
| Interior Evaluation : <span style="color: red;">C</span> | Exterior Evaluation : <span style="color: red;">D</span> |
|---|---|
| <p><b>a</b> : Cut, Fray <b>d</b> : Loose, Deformed <b>k</b> : Animal Hair <b>s</b> : Smell <b>t</b> : Cigarette Burns <b>x</b> : Defective <b>y</b> : Stain</p> | <p><b>A</b> : Scratch <b>AU</b> : Scratch &amp; Dent <b>B</b> : Modified <b>C</b> : Corrosion <b>G</b> : Stone chip <b>P</b> : Faded <b>S</b> : Rust <b>SC</b> : Rust &amp; Corrosion <b>U</b> : Dent <b>X</b> : Defective <b>Y</b> : Crack, Gap</p> |
| <b>Remarks</b><br>Rear Seat - Worn - Yes / Overall Interior - Smell - Yes / (L) Front Floor Mat - Worked - Small / (R) Front Floor Mat - Grime - Medium / (L) Front Seat - Fray - Medium / (R) Front Seat - Grime - Small / (L) Front Trim - Worked - Small / (R) Front Trim - Grime - Small / Ceiling - Crinkle - Small / Dashboard - Worked - Minimal | <b>Remarks</b><br>Front Panel - Scratch & Dent - Minimal / (L) Front Fender, Molding - Scratch - Minimal / (R) Front Fender, Molding - Scratch - Minimal / (R) Front Door, Molding - Scratch & Dent - Minimal / (R) Center Panel - Scratch - Small / (R) Step, In-panel, Side Spoiler - Scratch & Dent - Small / Front Bumper, Grille, Lamps - Scratch - Small / (L) Front Door, Molding - Scratch & Dent - Small / (L) Step, In-panel, Side Spoiler - Scratch - Medium / (L) Center Panel - Scratch & Dent - Minimal / (L) Side Gate - Scratch & Dent - Small / Rear Bumper, Lamps, Panels - Scratch & Dent - Medium / (R) Side Gate - Scratch & Dent - Medium / Rear Gate - Scratch & Dent - Small / Cargo Bed Floor - Rust, Corrosion - Medium |
