## General Information

| Make | Toyota | Model | Hiace |
| Registration No. | DBT8466 | Chassis No. | JTFJT02PXS5040203 |

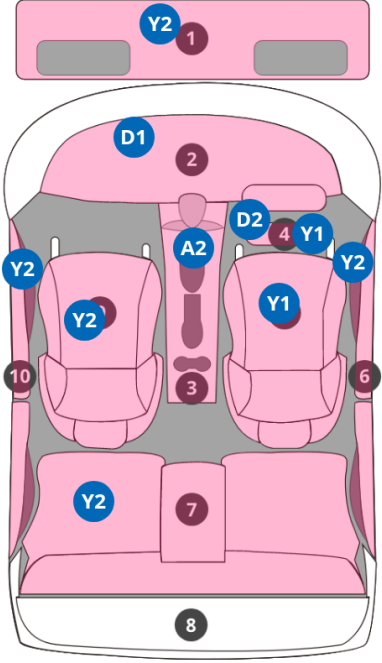
| Interior Evaluation : <b>B</b> | Exterior Evaluation : <b>D</b> |
|---|---|
| <p><b>Remarks</b><br/>Ceiling - Grime - Small / (L) Front Floor Mat - Worked - Small / (L) Front Seat - Grime - Small / (R) Front Seat - Grime - Minimal / Rear Seat - Grime - Small / Dashboard - Worked - Minimal / (L) Front Trim - Grime - Small / (R) Front Trim - Grime - Small / Knobs - Worn, Peel, Crack - Small / (R) Front Floor Mat - Grime - Minimal</p> | <p><b>Remarks</b><br/>Trunk Hood, Rear Gate - Partially Missing - Yes / (R) Step, In-panel, Side Spoiler - Scratch &amp; Dent - Small / (R) Front Door, Molding - Scratch - Minimal / (R) Mirror - Scratch, Peeled - Yes / (R) Rear Door, Molding - Scratch &amp; Dent - Large / (R) Rear Fender, Molding - Scratch &amp; Dent - Medium / Rear Bumper, Lamps, Panels - Dent - Small / (L) Rear Door, Molding - Scratch &amp; Dent - Medium / (L) Front Door, Molding - Scratch - Minimal / Roof - Scratch - Small / (L) Rear Fender, Molding - Scratch - Small / Front Panel - Scratch - Minimal / Front Bumper, Grille, Lamps - Scratch - Minimal</p> |

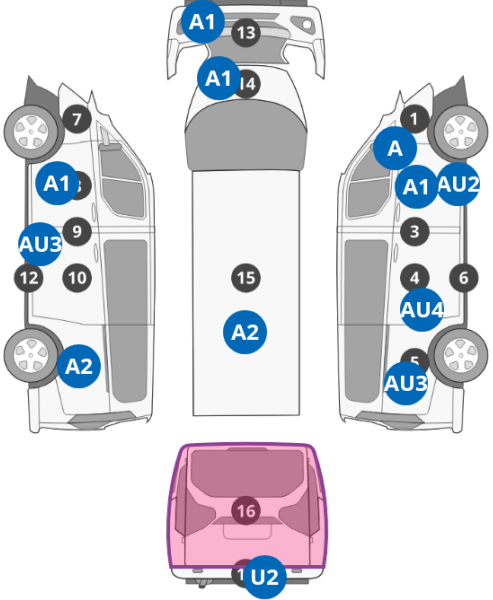
| Inspector Notes |
|---|
| with Ito plate/with manual no warranty booklet/with spare tire/with tools no jack/with hairlines scratches on the body/no reverse camera/no spare key |
