## General Information

| Make | Suzuki | Model | Dzire |

## Body / Panel Condition

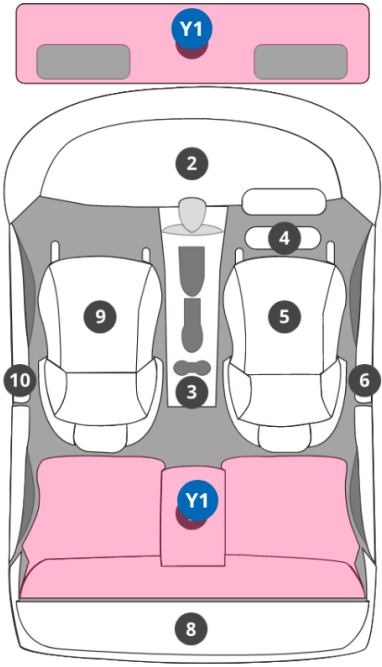
| <b>Remarks</b><br>Rear Seat - Grime - Minimal / Ceiling - Grime - Minimal | <b>Remarks</b><br>(L) Front Door, Molding - Dent - Small / Front Bumper, Grille, Lamps - Scratch & Dent - Medium / Rear Bumper, Lamps, Panels - Dent - Medium / (R) Front Door, Molding - Scratch & Dent - Small / (L) Step, In-panel, Side Spoiler - Scratch - Medium / (L) Front Fender, Molding - Dent - Medium |
