## General Information

| Make | Toyota | Model | Vios |
| Registration No. | EAJ7478 | Chassis No. | PA1B18F36R4275887 |

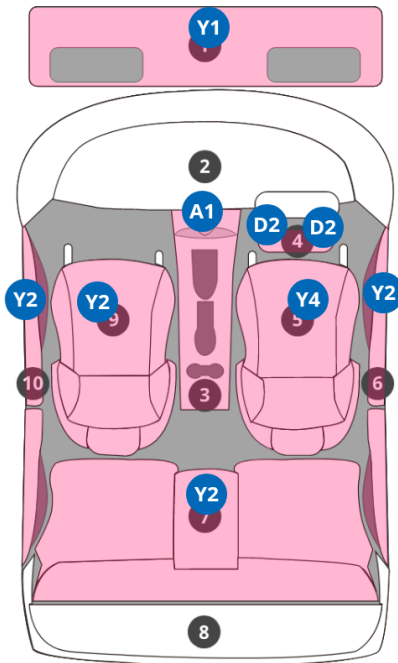
| Interior Evaluation : <b>C</b> | Exterior Evaluation : <b>E</b> |
|---|---|
| <p><b>Remarks</b></p> <p>(L) Front Trim - Grime - Small / (L) Front Floor Mat - Worked - Small / (R) Front Floor Mat - Worked - Small / (R) Front Trim - Grime - Small / (L) Front Seat - Grime - Small / Rear Seat - Grime - Small / (R) Front Seat - Grime - Large / Ceiling - Grime - Minimal / Console, Switchs, Vents - Worn, Scratch, Cut, Crack - Minimal</p> | <p><b>Remarks</b></p> <p>(R) Front Fender, Molding - Crack, Gap - Medium / (R) Mirror - Scratch - Small / (R) Step, In-panel, Side Spoiler - Scratch - Small / (R) Front Door, Molding - Scratch - Small / (R) Rear Door, Molding - Repair mark - Yes / (R) Rear Door, Molding - Scratch - Small / (R) Rear Fender, Molding - Scratch &amp; Dent - Small / Trunk Hood, Rear Gate - Scratch - Small / Rear Bumper, Lamps, Panels - Scratch - Medium / (L) Rear Fender, Molding - Scratch &amp; Dent - Small / (L) Step, In-panel, Side Spoiler - Scratch - Small / (L) Front Door, Molding - Scratch - Small / (L) Mirror - Scratch - Minimal / (L) Front Fender, Molding - Scratch - Small / Bonnet, Headlight - Scratch - Small / Front Bumper, Grille, Lamps - Scratch - Medium / Roof - Scratch - Small / (L) Rear Door, Molding - Scratch &amp; Dent - Small</p> |

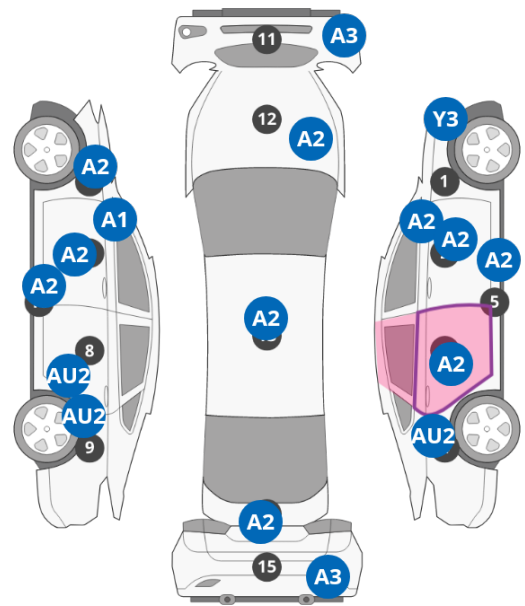
| Inspector Notes |
|---|
| with LTO plate/with warranty booklet/with incomplete tools with jack/with spare tire/hairline scratches on the body |
