## General Information

| Make | Toyota | Model | Hilux Tamaraw |
| YOM | 2025 | Odo Meter Reading | 22,984 |
| Registration No. | CDA7252 | Chassis No. | PAHAD9DA0S1627977 |

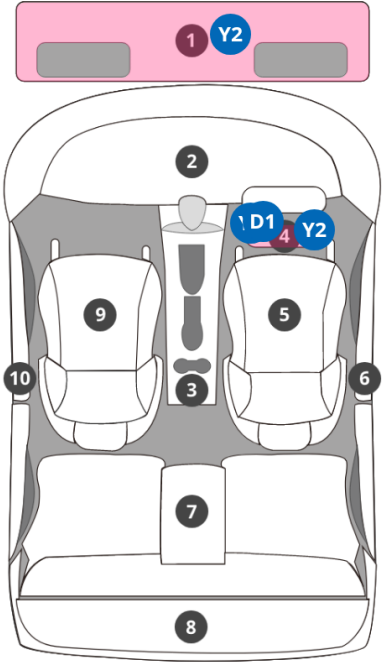
| Interior Evaluation : <b>A</b> | Exterior Evaluation : <b>E</b> |
|---|---|
| <p><b>Remarks</b><br/>(R) Front Floor Mat - Grime - Small / (L) Front Floor Mat - Grime - Small / Ceiling - Grime - Small / Carpet - Worked - Minimal</p> | <p><b>Remarks</b><br/>(L) Front Fender, Molding - Scratch - Small / (L) Mirror - Scratch - Minimal / (L) Front Door, Molding - Scratch - Small / (L) Step, In-panel, Side Spoiler - Scratch - Small / (L) Side Gate - Scratch - Medium / Rear Gate - Scratch &amp; Dent - Medium / Rear Bumper, Lamps, Panels - Scratch - Medium / (R) Side Gate - Scratch - Large / (R) Step, In-panel, Side Spoiler - Scratch - Small / (R) Mirror - Scratch - Small / (R) Front Door, Molding - Scratch &amp; Dent - Small / (R) Front Fender, Molding - Scratch - Small / Front Bumper, Grille, Lamps - Scratch &amp; Dent - Medium / Bonnet, Headlight - Scratch - Small / Front Windshield - Damaged - Large / Cargo Bed Floor - Scratch &amp; Dent - Large / Roof - Scratch &amp; Dent - Small / (L) Side Gate - Repair mark - Yes / Rear Gate - Repair mark - Yes</p> |
