## General Information

| Make | Toyota | Model | Vios |
| YOM | 2024 | Odo Meter Reading | 41,321 |
| Registration No. | NEY4490 | Chassis No. | PA1B18F30R4257112 |

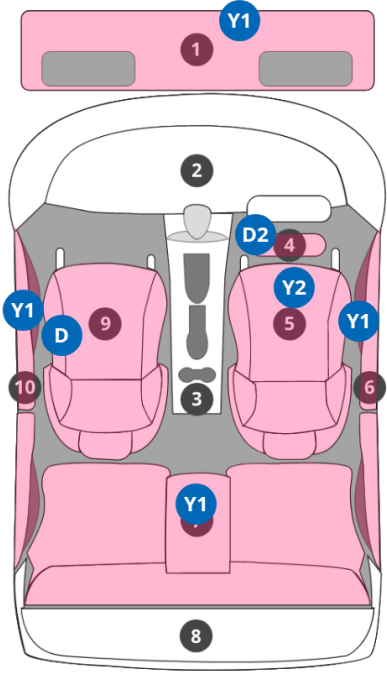
| Interior Evaluation : <b>B</b> | Exterior Evaluation : <b>C</b> |
| <p><b>Remarks</b><br/>(L) Front Floor Mat - Worked - Small / (L) Front Seat - Worn - Yes / (R) Front Seat - Grime - Small / Ceiling - Grime - Minimal / Rear Seat - Grime - Minimal / (R) Front Trim - Grime - Minimal / (L) Front Trim - Grime - Minimal</p> | <p><b>Remarks</b><br/>(R) Front Fender - Repair Traces - Yes / Bonnet - Repair Traces - Yes / (L) Front Fender - Repair Traces - Yes / (R) Mirror - Scratch - Small / (R) Front Fender, Molding - Scratch - Minimal / (R) Rear Door, Molding - Scratch - Small / (R) Front Door, Molding - Scratch - Small / (R) Rear Fender, Molding - Scratch - Minimal / Rear Bumper, Lamps, Panels - Scratch - Small / Trunk Hood, Rear Gate - Scratch - Small / (L) Rear Fender, Molding - Scratch - Small / (L) Front Door, Molding - Scratch &amp; Dent - Small / (L) Rear Door, Molding - Scratch - Minimal / (L) Mirror - Scratch - Small / Member (Bolted) - Dent - Yes / (L) Front Fender, Molding - Scratch - Minimal / Front Bumper, Grille, Lamps - Repair mark - Yes / Front Bumper, Grille, Lamps - Scratch - Small / Bonnet, Headlight - Scratch - Small / Roof - Scratch - Minimal</p> |
