## General Information

| Make | Toyota | Model | Innova |
| Registration No. | NFR7748 | Chassis No. | PA2JA8EM9R0142081 |

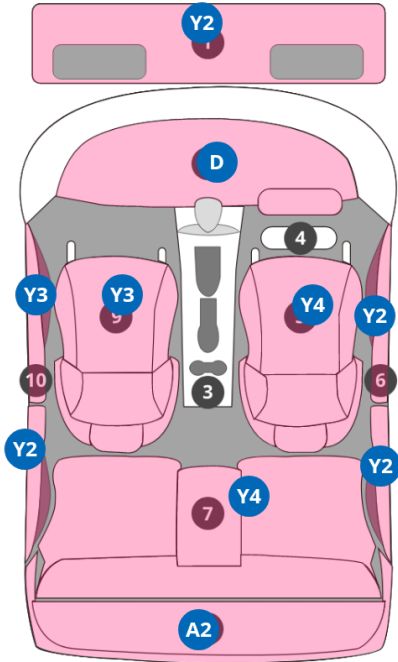
| Interior Evaluation : <span style="color: red;">D</span> | Exterior Evaluation : <span style="color: red;">E</span> |
|---|---|
| <p><b>a</b> : Cut, Fray <b>d</b> : Loose, Deformed <b>k</b> : Animal Hair <b>s</b> : Smell <b>t</b> : Cigarette Burns <b>x</b> : Defective <b>y</b> : Stain</p> | <p><b>A</b> : Scratch <b>AU</b> : Scratch &amp; Dent <b>B</b> : Modified <b>C</b> : Corrosion <b>G</b> : Stone chip <b>P</b> : Faded <b>S</b> : Rust <b>SC</b> : Rust &amp; Corrosion <b>U</b> : Dent <b>X</b> : Defective <b>Y</b> : Crack, Gap</p> |
| <b>Remarks</b><br>(R) Front Seat - Grime - Large / (R) Front Trim - Grime - Small / Rear Seat - Grime - Large / (R) Rear Trim - Grime - Small / Trunk Room - Worn, Scratch, Cut, Crack - Small / (L) Rear Trim - Grime - Small / (L) Front Trim - Grime - Medium / (L) Front Seat - Grime - Medium / Dashboard - Traces of Adhesive Tape - Yes / Ceiling - Grime - Small | <b>Remarks</b><br>(R) Front Fender, Molding - Scratch - Minimal / (R) Mirror - Scratch - Minimal / (R) Front Door, Molding - Scratch - Medium / (R) Rear Door, Molding - Scratch - Small / (R) Rear Fender, Molding - Scratch - Small / Rear Bumper, Lamps, Panels - Scratch - Large / Trunk Hood, Rear Gate - Scratch & Dent - Small / (L) Rear Fender, Molding - Scratch - Small / (L) Rear Door, Molding - Scratch - Medium / (L) Front Door, Molding - Scratch - Small / (L) Front Fender, Molding - Scratch - Small / Front Bumper, Grille, Lamps - Scratch - Large / Bonnet, Headlight - Scratch - Medium / Roof - Scratch & Dent - Small |
