## General Information

| Make | Toyota | Model | Avanza |
| Registration No. | NFR2596 | Chassis No. | MHFAA1BY2R0024621 |

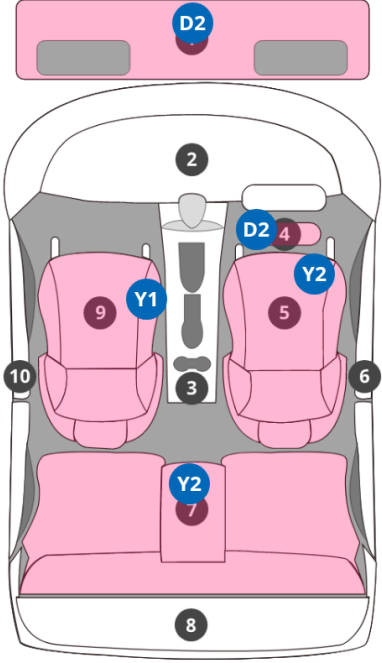
| Interior Evaluation : <b>B</b> | Exterior Evaluation : <b>E</b> |
|---|---|
| <p><b>Remarks</b><br/>Ceiling - Crinkle - Small / (R) Front Seat - Grime - Small / (L) Front Floor Mat - Worked - Small / (L) Front Seat - Grime - Minimal / Rear Seat - Grime - Small</p> | <p><b>Remarks</b><br/>(R) Front Fender, Molding - Scratch - Small / (R) Mirror - Scratch - Small / (R) Front Door, Molding - Scratch - Medium / (R) Step, In-panel, Side Spoiler - Scratch &amp; Dent - Large / (R) Rear Door, Molding - Scratch &amp; Dent - Large / (R) Rear Fender, Molding - Scratch - Small / Rear Bumper, Lamps, Panels - Scratch &amp; Dent - Medium / Trunk Hood, Rear Gate - Scratch - Small / (L) Rear Fender, Molding - Scratch - Large / (L) Rear Door, Molding - Scratch - Medium / (L) Step, In-panel, Side Spoiler - Scratch &amp; Dent - Large / (L) Front Door, Molding - Scratch - Medium / (L) Mirror - Scratch - Minimal / (L) Front Fender, Molding - Scratch &amp; Dent - Large / Front Bumper, Grille, Lamps - Scratch - Large / Bonnet, Headlight - Scratch - Small / Roof - Scratch - Small</p> |

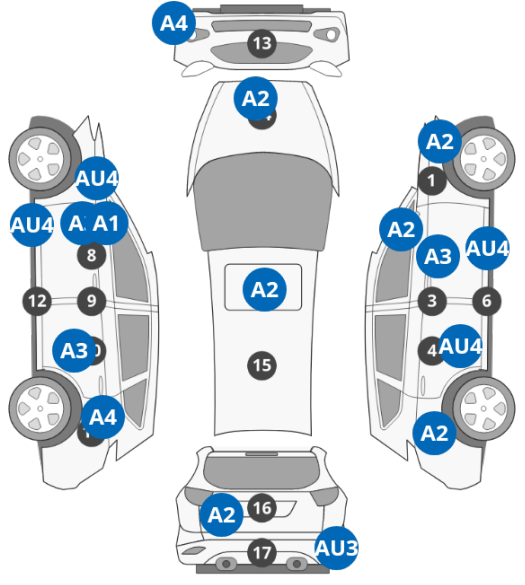
| Inspector Notes |
|---|
| with warranty booklet and jack, incomplete tools, with spare tire, with LTO plate, scratches on tail light, touch up/ repair mark on some panel |
