## General Information

| Make | Toyota | Model | Vios |
| YOM | 2025 | Odo Meter Reading | 91,358 |

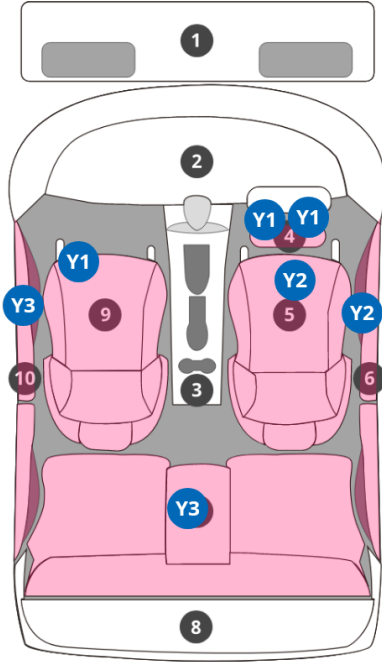
| Interior Evaluation : <b>B</b> | Exterior Evaluation : <b>D</b> |
|---|---|
| <p><b>Remarks</b></p> <p>(R) Front Trim - Grime - Small / (R) Front Seat - Grime - Small / (R) Front Floor Mat - Grime - Minimal / Rear Seat - Grime - Medium / (L) Front Trim - Grime - Medium / (L) Front Floor Mat - Grime - Minimal / (L) Front Seat - Grime - Minimal</p> | <p><b>Remarks</b></p> <p>(L) Front Fender, Molding - Crack, Gap - Small / (L) Step, In-panel, Side Spoiler - Scratch - Small / (L) Mirror - Scratch - Small / (L) Front Door, Molding - Scratch - Small / (L) Rear Door, Molding - Scratch - Small / (L) Rear Fender, Molding - Scratch - Minimal / Rear Bumper, Lamps, Panels - Scratch - Small / Trunk Hood, Rear Gate - Scratch - Small / (R) Rear Fender, Molding - Scratch &amp; Dent - Small / (R) Rear Door, Molding - Scratch &amp; Dent - Small / (R) Step, In-panel, Side Spoiler - Scratch - Small / (R) Front Door, Molding - Scratch - Small / (R) Front Fender, Molding - Crack, Gap - Medium / Front Bumper, Grille, Lamps - Scratch - Medium / Bonnet, Headlight - Scratch &amp; Dent - Medium / Roof - Scratch - Small</p> |
