## General Information

| Make | Toyota | Model | Vios |
| YOM | 2025 | Odo Meter Reading | 13,399 |
| Registration No. | NJA2785 | Chassis No. | PA1B18F36S4281694 |

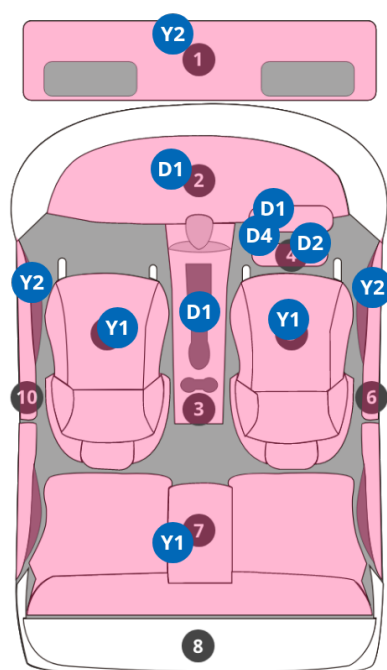
| <div> <div>Interior Evaluation :</div> <div>C</div> </div> | <div> <div>Exterior Evaluation :</div> <div>C</div> </div> |
| <div> <p> <b>a</b> : Cut, Fray   <b>d</b> : Loose, Deformed   <b>k</b> : Animal Hair   <b>s</b> : Smell   <b>t</b> : Cigarette Burns   <b>x</b> : Defective   <b>y</b> : Stain </p> </div> | <div> <p> <b>A</b> : Scratch   <b>AU</b> : Scratch &amp; Dent   <b>B</b> : Modified   <b>C</b> : Corrosion   <b>G</b> : Stone chip   <b>P</b> : Faded   <b>S</b> : Rust   <b>SC</b> : Rust &amp; Corrosion   <b>U</b> : Dent   <b>X</b> : Defective   <b>Y</b> : Crack, Gap </p> </div> |
| <div> <div>Remarks</div> <div>Ceiling - Grime - Small / Dashboard - Worked - Minimal / Glove Box - Loose, Deformed - Minimal / (R) Front Trim - Grime - Small / (L) Front Trim - Grime - Small / (L) Front Seat - Grime - Minimal / (R) Front Seat - Grime - Minimal / (R) Front Floor Mat - Worked - Large / (L) Front Floor Mat - Worked - Small / Rear Seat - Grime - Minimal / Console, Switches, Vents - Worked - Minimal</div> </div> | <div> <div>Remarks</div> <div>(R) Front Fender, Molding - Scratch &amp; Dent - Small / (R) Mirror - Scratch, Peeled - Minimal / (R) Front Door, Molding - Scratch - Minimal / (R) Step, In-panel, Side Spoiler - Scratch - Minimal / (R) Rear Door, Molding - Scratch - Minimal / (R) Rear Fender, Molding - Scratch - Small / Rear Bumper, Lamps, Panels - Scratch - Small / Trunk Hood, Rear Gate - Scratch - Minimal / Roof - Scratch - Minimal / (L) Rear Fender, Molding - Scratch - Minimal / (L) Step, In-panel, Side Spoiler - Scratch - Minimal / (L) Mirror - Scratch - Minimal / (L) Front Fender, Molding - Scratch - Minimal / Bonnet, Headlight - Scratch - Minimal / Front Bumper, Grille, Lamps - Crack, Gap - Medium / (R) Side Window - Damaged - Small</div> </div> |
