## General Information

| Make | Toyota | Model | Hilux Tamaraw |

## Body / Panel Condition

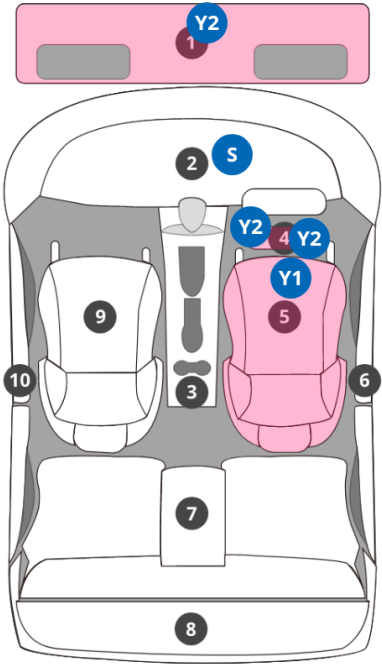
| Interior Evaluation : <b>B</b> | Exterior Evaluation : <b>E</b> |
|---|---|
| <b>Remarks</b><br>Ceiling - Grime - Small / (R) Front Seat - Grime - Minimal / (R) Front Floor Mat - Grime - Small / (L) Front Floor Mat - Grime - Small / Overall Interior - Smell - Yes | <b>Remarks</b><br>(L) Front Fender, Molding - Scratch - Small / (L) Mirror - Scratch - Minimal / (L) Step, In-panel, Side Spoiler - Scratch - Small / (L) Front Door, Molding - Scratch - Small / (L) Side Gate - Scratch & Dent - Large / Roof - Scratch & Dent - Small / Rear Bumper, Lamps, Panels - Scratch - Large / Rear Gate - Scratch - Small / Cargo Bed Floor - Scratch - Large / (R) Side Gate - Scratch & Dent - Large / (R) Front Door, Molding - Scratch - Medium / (R) Step, In-panel, Side Spoiler - Scratch - Small / (R) Mirror - Scratch - Minimal / (R) Front Fender, Molding - Scratch - Small / Front Bumper, Grille, Lamps - Scratch - Medium / Bonnet, Headlight - Scratch - Minimal |
