## General Information

| Make | Toyota | Model | Hilux Tamaraw |
| YOM | 2025 | Odo Meter Reading | 16,486 |
| Registration No. | NJQ2321 | Chassis No. | PAHACACA9S6424921 |

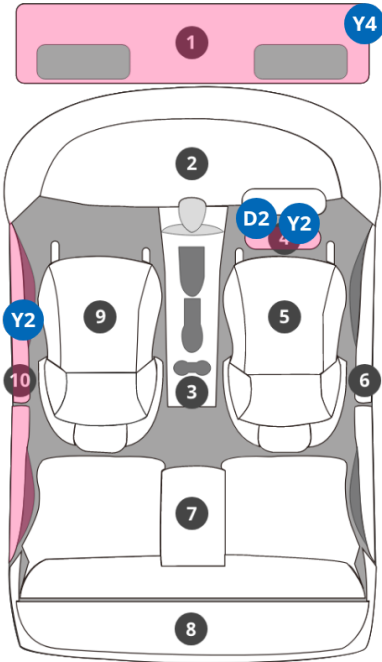
| Interior Evaluation : <span style="color: red; font-weight: bold;">C</span> | Exterior Evaluation : <span style="color: red; font-weight: bold;">E</span> |
|---|---|
| <b>Remarks</b><br>(L) Front Trim - Grime - Small / Ceiling - Grime - Large / (L) Front Floor Mat - Worked - Small / (R) Front Floor Mat - Grime - Small | <b>Remarks</b><br>(R) Front Fender, Molding - Scratch - Small / (R) Mirror - Scratch - Small / (R) Front Door, Molding - Scratch - Small / (R) Center Panel - Scratch - Minimal / (R) Side Gate - Scratch & Dent - Large / Rear Gate - Scratch - Medium / (L) Side Gate - Scratch & Dent - Large / Rear Bumper, Lamps, Panels - Scratch - Medium / Cab Back Panel - Scratch - Medium / Cargo Bed Floor - Scratch & Dent - Medium / (L) Front Door, Molding - Scratch - Medium / (L) Center Panel - Scratch - Minimal / (L) Mirror - Scratch - Small / (L) Front Fender, Molding - Scratch - Small / Bonnet, Headlight - Scratch - Minimal / Front Bumper, Grille, Lamps - Scratch - Medium / Roof - Dent - Large |

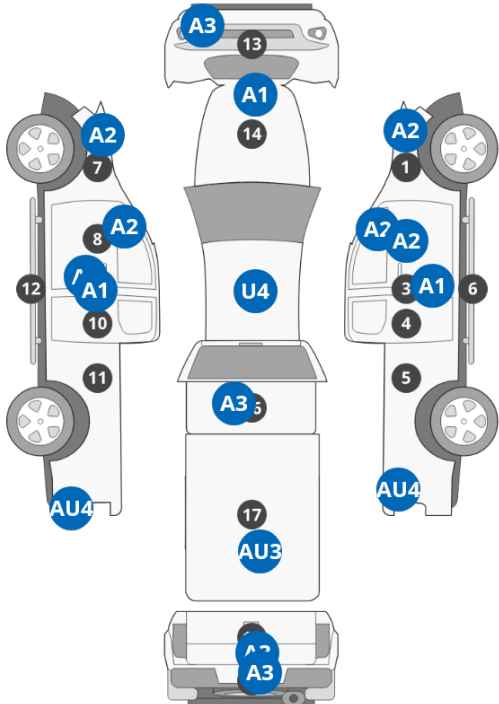
with warranty and jack, no tools, with spare tire, with LTO plate but not attached, scratches on tail light
