## General Information

| Make | Toyota | Model | Vios |
| Registration No. | NKE8569 | Chassis No. | PA1B18F35R4266341 |

## Overall Evaluation :

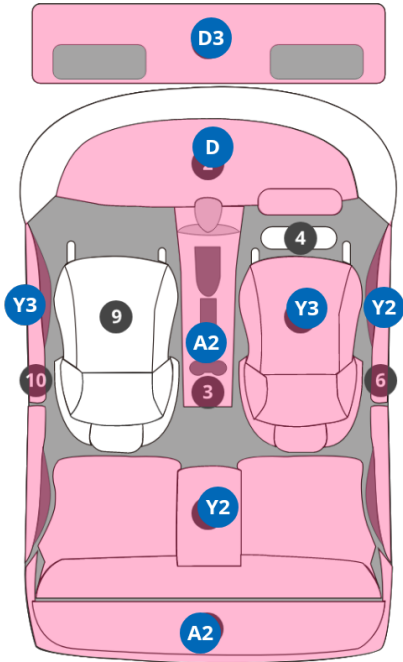
| Interior Evaluation : <b>C</b> | Exterior Evaluation : <b>E</b> |
|---|---|
| <p><b>Remarks</b></p> <p>(R) Front Seat - Grime - Medium / (R) Front Trim - Grime - Small / Rear Seat - Grime - Small / Trunk Room - Worn, Scratch, Cut, Crack - Small / (L) Front Trim - Grime - Medium / Console, Switches, Vents - Worn, Scratch, Cut, Crack - Small / Ceiling - Crinkle - Medium / Dashboard - Traces of Adhesive Tape - Yes</p> | <p><b>Remarks</b></p> <p>(R) Front Door - Repair Traces - Yes / (R) Front Fender - Repair Traces - Yes / Bonnet - Repair Traces - Yes / (L) Front Fender - Repair Traces - Yes / Trunk Hood, Rear Gate - Repair Traces - Yes / (R) Rear Fender - Repair Traces - Yes / (R) Rear Door - Repair Traces - Yes / Roof - Repair Traces - Yes / Trunk Hood, Rear Gate - Scratch &amp; Dent - Small / Rear Bumper, Lamps, Panels - Scratch - Large / (L) Rear Fender, Molding - Scratch - Medium / (L) Rear Door, Molding - Scratch - Small / (L) Front Door, Molding - Scratch - Small / (L) Mirror - Scratch - Minimal / (L) Front Fender, Molding - Scratch - Minimal / Bonnet, Headlight - Scratch - Small / Front Bumper, Grille, Lamps - Scratch &amp; Dent - Large / (R) Front Fender, Molding - Crack, Gap - Medium / (R) Front Fender, Molding - Repair mark - Yes / (R) Front Door, Molding - Repair mark - Yes / (R) Front Door, Molding - Scratch - Medium / (R) Step, In-panel, Side Spoiler - Scratch - Minimal / (R) Rear Door, Molding - Scratch &amp; Dent - Medium / (R) Rear Fender, Molding - Scratch &amp; Dent - Large / Roof - Scratch - Small</p> |
