## General Information

| Make | Toyota | Model | Hilux Tamaraw |

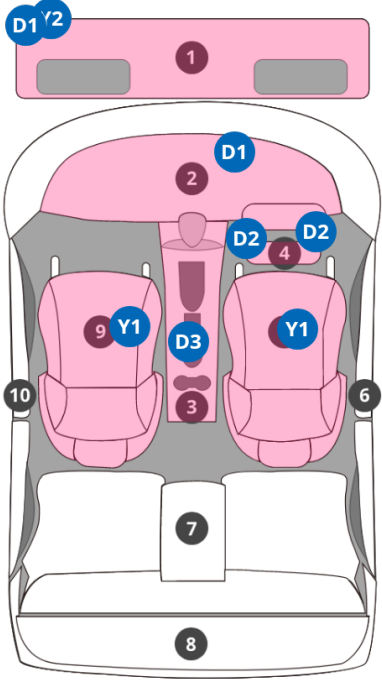
| Interior Evaluation : <b>B</b> | Exterior Evaluation : <b>C</b> |
| <b>Remarks</b><br>Ceiling - Grime - Small / Sunvisor, Sunglass Holder - Loose, Deformed - Minimal / Dashboard - Worked - Minimal / (L) Front Floor Mat - Worked - Small / (R) Front Floor Mat - Worked - Small / Console, Switches, Vents - Loose, Deformed - Medium / (L) Front Seat - Grime - Minimal / (R) Front Seat - Grime - Minimal | <b>Remarks</b><br>Front Bumper, Grille, Lamps - Crack, Gap - Medium / Bonnet, Headlight - Scratch - Minimal / (R) Front Door, Molding - Scratch - Minimal / (R) Step, In-panel, Side Spoiler - Scratch - Minimal / (R) Guard Frame - Scratch & Dent - Medium / Rear Gate - Scratch - Minimal / Cargo Bed Floor - Scratch - Small / (L) Guard Frame - Scratch & Dent - Medium / (L) Mirror - Crack - Damaged / (L) Front Door, Molding - Scratch - Minimal / (L) Step, In-panel, Side Spoiler - Scratch - Minimal / Roof - Dent - Small |
