## General Information

| Make | Toyota | Model | Hilux Tamaraw |
| Registration No. | NKQ5468 | Chassis No. | PAHACACA9S6422134 |

## Body / Panel Condition

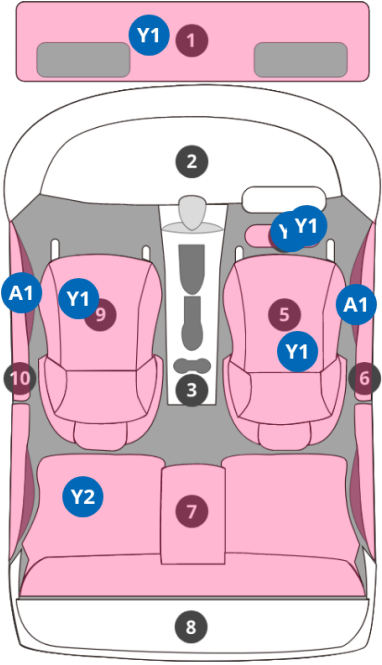
| Interior Evaluation : <span style="color: red; font-weight: bold;">A</span> | Exterior Evaluation : <span style="color: red; font-weight: bold;">E</span> |
| <b>Remarks</b><br>(L) Front Seat - Grime - Minimal / (R) Front Seat - Grime - Minimal / (L) Front Floor Mat - Grime - Minimal / (R) Front Floor Mat - Grime - Minimal / (L) Front Trim - Cut, Crack - Minimal / (R) Front Trim - Cut, Crack - Minimal / Rear Seat - Grime - Small / Ceiling - Grime - Minimal | <b>Remarks</b><br>(R) Front Door, Molding - Scratch - Medium / Bonnet, Headlight - Scratch & Dent - Minimal / Front Bumper, Grille, Lamps - Scratch - Medium / (L) Front Fender, Molding - Scratch & Dent - Minimal / (L) Front Door, Molding - Scratch & Dent - Medium / (L) Step, In-panel, Side Spoiler - Scratch - Small / (L) Side Gate - Scratch & Dent - Medium / (L) Guard Frame - Scratch & Dent - Medium / Rear Gate - Scratch - Small / Rear Bumper, Lamps, Panels - Scratch - Small / (R) Guard Frame - Scratch & Dent - Large / (R) Side Gate - Scratch & Dent - Minimal / (R) Rear Door, Molding - Scratch - Medium / Roof - Dent - Medium / Cargo Bed Floor - Scratch - Small |

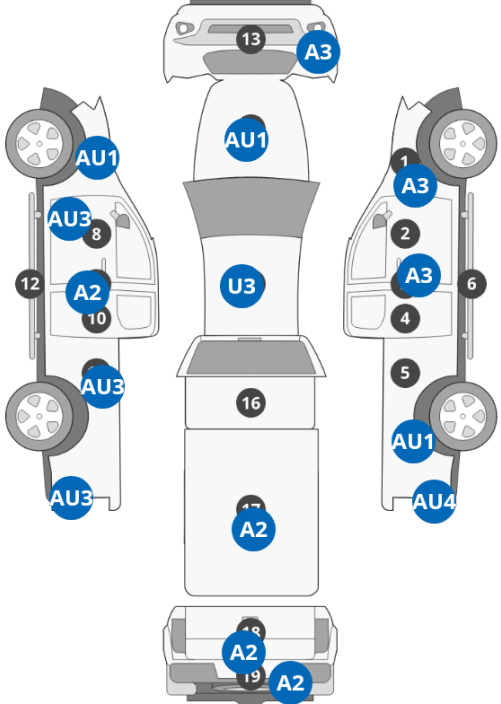
with LTO plate, with spare tire, no tools and jack, no warranty and manual booklet, no spare key, no reverse camera, scratches on taillight and headlight, scratches and dent on exterior.
