## General Information

| Make | Toyota | Model | Hilux Tamaraw |

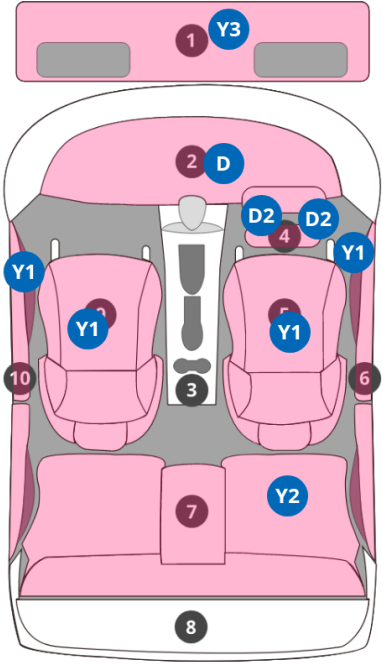
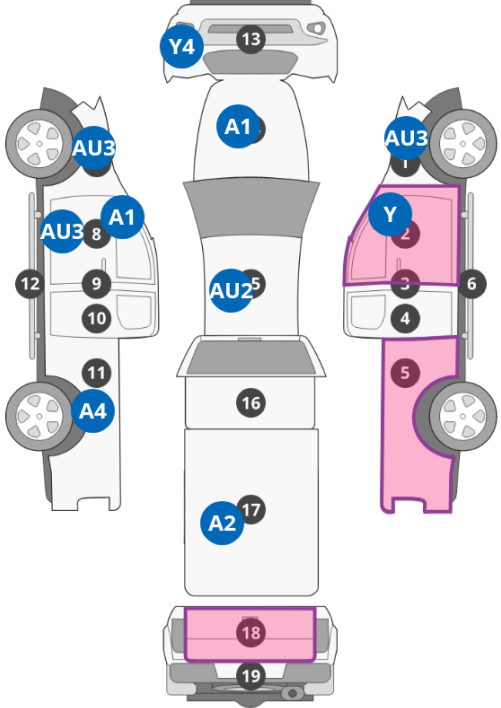
| Interior Evaluation : <b>B</b> | Exterior Evaluation : <b>E</b> |
|---|---|
| <p><b>a</b> : Cut, Fray <b>d</b> : Loose, Deformed <b>k</b> : Animal Hair <b>s</b> : Smell <b>t</b> : Cigarette Burns <b>x</b> : Defective <b>y</b> : Stain</p> | <p><b>A</b> : Scratch <b>AU</b> : Scratch &amp; Dent <b>B</b> : Modified <b>C</b> : Corrosion <b>G</b> : Stone chip <b>P</b> : Faded <b>S</b> : Rust <b>SC</b> : Rust &amp; Corrosion <b>U</b> : Dent <b>X</b> : Defective <b>Y</b> : Crack, Gap</p> |
| <p><b>Remarks</b></p> <p>Ceiling - Grime - Medium / Dashboard - Traces of Adhesive Tape - Yes / (R) Front Floor Mat - Worked - Small / (L) Front Floor Mat - Worked - Small / (L) Front Trim - Grime - Minimal / (R) Front Trim - Grime - Minimal / Rear Seat - Grime - Small / (L) Front Seat - Grime - Minimal / (R) Front Seat - Grime - Minimal</p> | <p><b>Remarks</b></p> <p>(R) Front Fender, Molding - Scratch &amp; Dent - Medium / (R) Front Door, Molding - Repair mark - Difference in Color / (R) Guard Frame - Repair mark - Difference in Color / Rear Gate - Repair mark - Difference in Color / (L) Guard Frame - Scratch - Large / (L) Front Door, Molding - Scratch &amp; Dent - Medium / (L) Front Fender, Molding - Scratch &amp; Dent - Medium / Front Bumper, Grille, Lamps - Crack, Gap - Large / Bonnet, Headlight - Scratch - Minimal / Roof - Scratch &amp; Dent - Small / Cargo Bed Floor - Scratch - Small / (R) Mirror - Crack - Damaged / (L) Mirror - Scratch, Peeled - Minimal</p> |
