## General Information

| Make | Nissan | Model | NV350 |
| Registration No. | LAC4076 | Chassis No. | JN1TC2E26Z0052244 |

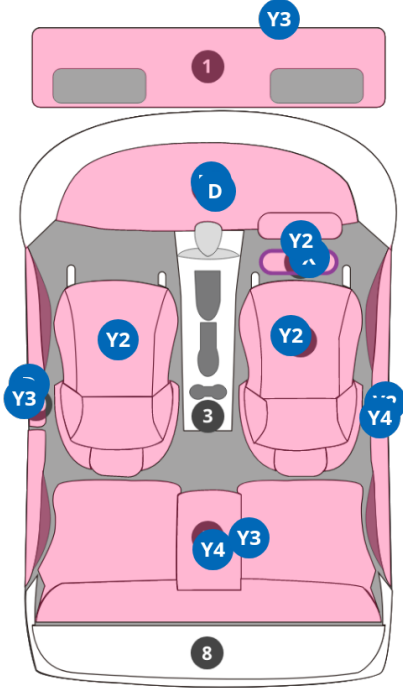
| Interior Evaluation : <b>E</b> | Exterior Evaluation : <b>E</b> |
| <p><b>Remarks</b></p> <p>(L) Front Floor Mat - Missing - Yes / (R) Front Floor Mat - Grime - Small / Glove Box - Loose, Deformed - Small / Ceiling - Grime - Medium / (R) Front Trim - Repair Mark - Yes / (R) Front Trim - Grime - Small / (R) Front Seat - Grime - Small / Rear Seat - Grime - Large / Seat belt Other - Grime - Medium / (R) Rear Trim - Grime - Large / (L) Front Seat - Grime - Small / (L) Front Trim - Repair Mark - Yes / (L) Front Trim - Grime - Medium / Dashboard - Repair Mark - Yes</p> | <p><b>Remarks</b></p> <p>(L) Rear Fender, Molding - Scratch - Large / (L) Mirror - Scratch - Small / (L) Front Door, Molding - Scratch - Medium / Front Bumper, Grille, Lamps - Scratch &amp; Dent - Large / Bonnet, Headlight - Scratch - Small / (R) Mirror - Scratch - Medium / (R) Front Door, Molding - Scratch - Large / (R) Rear Door, Molding - Scratch &amp; Dent - Large / (R) Step, In-panel, Side Spoiler - Scratch &amp; Dent - Large / (R) Center Panel - Scratch - Medium / (R) Rear Fender, Molding - Scratch - Medium / Rear Bumper, Lamps, Panels - Scratch &amp; Dent - Medium / Trunk Hood, Rear Gate - Crack, Gap - Medium / Front Windshield - Damaged - Large / (L) Side Window - Scratch, Stone chip - Large / (L) Step, In-panel, Side Spoiler - Scratch - Large</p> |
