## General Information

| Make | Toyota | Model | Avanza |

## Body / Panel Condition

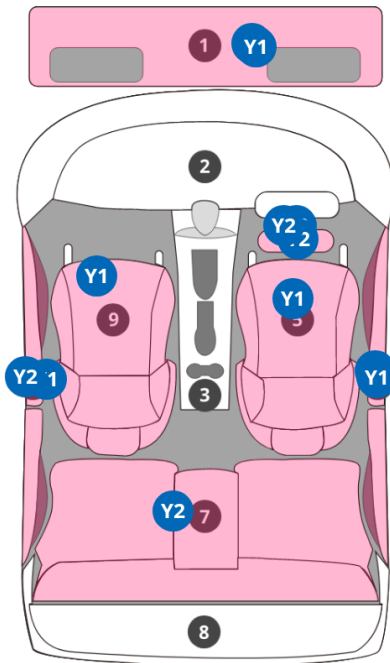
| Interior Evaluation : <b>B</b> | Exterior Evaluation : <b>E</b> |
| <p><b>a</b> : Cut, Fray <b>d</b> : Loose, Deformed <b>k</b> : Animal Hair <b>s</b> : Smell <b>t</b> : Cigarette Burns <b>x</b> : Defective <b>y</b> : Stain</p> | <p><b>A</b> : Scratch <b>AU</b> : Scratch &amp; Dent <b>B</b> : Modified <b>C</b> : Corrosion <b>G</b> : Stone chip <b>P</b> : Faded <b>S</b> : Rust <b>SC</b> : Rust &amp; Corrosion <b>U</b> : Dent <b>X</b> : Defective <b>Y</b> : Crack, Gap</p> |
| <b>Remarks</b><br>(R) Front Trim - Grime - Small / (L) Front Trim - Grime - Minimal / (R) Front Floor Mat - Grime - Small / (L) Front Floor Mat - Grime - Small / (R) Front Seat - Grime - Minimal / (L) Front Seat - Grime - Minimal / Overall Interior - Animal Hair - Yes / Ceiling - Grime - Minimal / Rear Seat - Grime - Small / Mat Other - Grime - Small / (R) Rear Trim - Grime - Minimal / (L) Rear Trim - Grime - Small | <b>Remarks</b><br>(L) Rear Door, Molding - Scratch - Medium / (L) Front Fender, Molding - Scratch - Small / (L) Mirror - Scratch - Small / (L) Front Door, Molding - Scratch - Small / Front Bumper, Grille, Lamps - Scratch - Large / Bonnet, Headlight - Scratch - Medium / (R) Front Fender, Molding - Scratch - Large / (R) Mirror - Scratch - Medium / (R) Front Door, Molding - Scratch - Large / (R) Rear Door, Molding - Scratch - Medium / (R) Step, In-panel, Side Spoiler - Scratch - Medium / (R) Rear Fender, Molding - Scratch & Dent - Small / Rear Bumper, Lamps, Panels - Scratch - Medium / Trunk Hood, Rear Gate - Scratch & Dent - Large / (L) Step, In-panel, Side Spoiler - Scratch - Small / (L) Rear Fender, Molding - Scratch - Small |

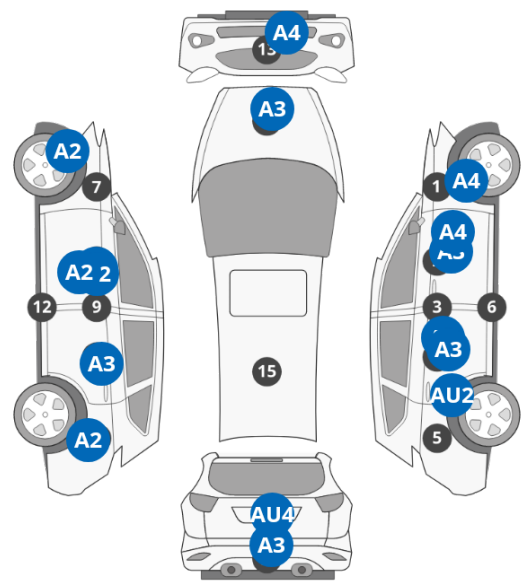
| Inspector Notes |
|---|
| Possible flooded. Incomplete tools. Dent at rear gate trunk. Without seatcover. With warranty booklet, jack, sparetire, LTO plate and 2keys. |
