## General Information

| Make | Toyota | Model | Vios |
| Registration No. | GBK4558 | Chassis No. | PA1B18F32S4296449 |

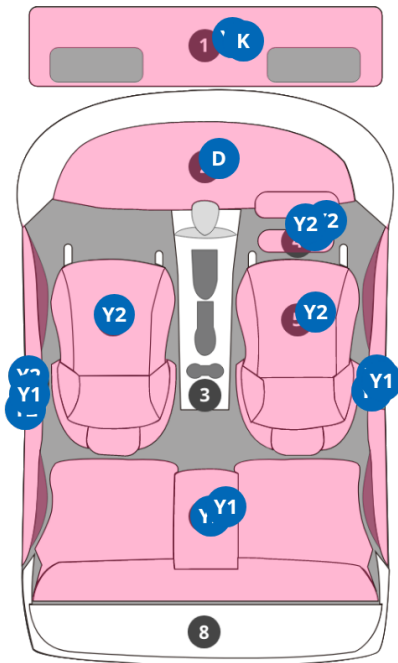
| Interior Evaluation : <span style="color: red;">C</span> | Exterior Evaluation : <span style="color: red;">E</span> |
| <b>Remarks</b><br>(L) Front Seat - Grime - Small / (L) Front Trim - Grime - Small / (L) Rear Trim - Grime - Small / Rear Seat - Grime - Small / (R) Rear Trim - Grime - Minimal / (R) Front Trim - Grime - Small / (R) Front Seat - Grime - Small / (L) Front Floor Mat - Grime - Small / (R) Front Floor Mat - Grime - Small / Mat Other - Grime - Small / Ceiling - Grime - Medium / Dashboard - Traces of Adhesive Tape - Yes / Overall Interior - Animal Hair - Yes / Trim Other - Grime - Minimal / Trim Other - Grime - Minimal / Trim Other - Grime - Minimal | <b>Remarks</b><br>(L) Mirror - Scratch - Small / (L) Front Fender, Molding - Scratch - Small / Front Bumper, Grille, Lamps - Scratch & Dent - Large / Bonnet, Headlight - Scratch - Minimal / (R) Front Fender, Molding - Scratch - Medium / (R) Mirror - Scratch - Minimal / (R) Front Door, Molding - Scratch - Large / (R) Step, In-panel, Side Spoiler - Scratch & Dent - Large / (R) Rear Door, Molding - Scratch - Large / (R) Rear Fender, Molding - Scratch & Dent - Medium / Roof - Scratch & Dent - Large / Rear Bumper, Lamps, Panels - Scratch - Large / Trunk Hood, Rear Gate - Scratch - Minimal / (L) Rear Fender, Molding - Dent - Large / (L) Rear Door, Molding - Scratch - Medium / (L) Step, In-panel, Side Spoiler - Scratch - Minimal / (L) Front Door, Molding - Scratch - Large |

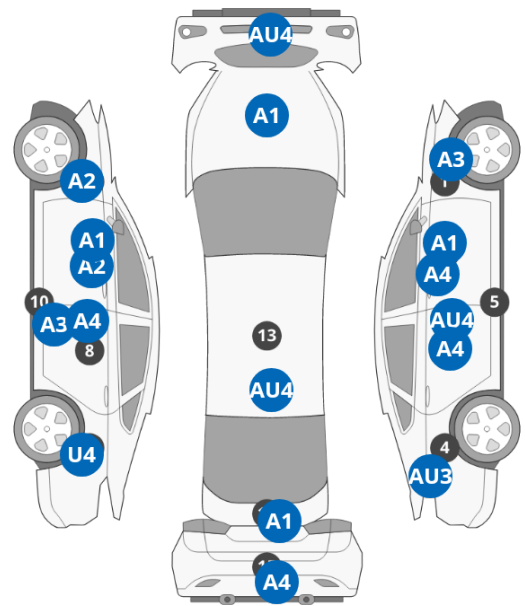
Possible flooded. Left side Taillight Crack, Driver side seatcover missing. Large dent at roof, front bumper and left side rear fender molding. Incomplete tools. Without warranty booklet, LTO plate. With jack, sparetire, seatcover and 1key.
