## General Information

| Make | Toyota | Model | Wigo |

## Body / Panel Condition

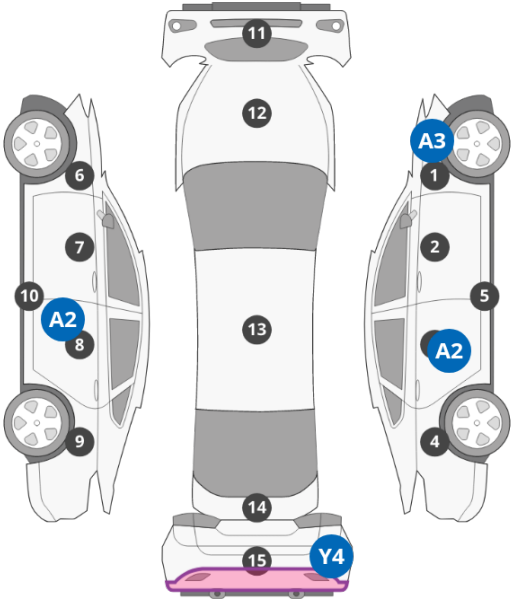
| <b>Remarks</b><br>Ceiling - Grime - Minimal | <b>Remarks</b><br>Rear Bumper, Lamps, Panels - Repair mark - Difference in Color / Trunk Hood, Rear Gate - Crack, Gap - Large / (R) Front Fender, Molding - Scratch - Medium / (R) Rear Door, Molding - Scratch - Small / (L) Rear Door, Molding - Scratch - Small |

with Ito plate, no warranty booklet, no jack, no tools, no spare tire, with hairlike scratches in the body.
