## General Information

| Make | Toyota | Model | Vios |
| Registration No. | ZAB8473 | Chassis No. | PA1B13F33K4095811 |

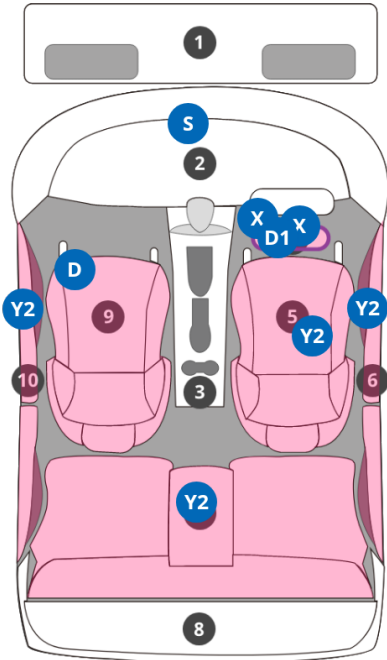
| <div>Interior Evaluation :<div>C</div></div> | <div>Exterior Evaluation :<div>E</div></div> |
| <div>Remarks<div>(R) Front Floor Mat - Missing - Yes / (L) Front Floor Mat - Missing - Yes / Carpet - Worked - Minimal / (L) Front Seat - Worn - Yes / Rear Seat - Grime - Small / (R) Front Seat - Grime - Small / (R) Front Trim - Grime - Small / (L) Front Trim - Grime - Small / Overall Interior - Smell - Yes / Overall Interior - Worn as per age - Yes</div></div> | <div>Remarks<div>(R) Step - Repair Traces - Yes / (R) Front Fender - Repair Traces - Yes / Bonnet - Repair Traces - Yes / (L) Front Fender - Repair Traces - Yes / (R) Rear Door - Repair Traces - Yes / Roof - Repair Traces - Yes / (R) Rear Fender, Molding - Scratch - Medium / (R) Front Fender, Molding - Repair mark - Yes / (R) Front Fender, Molding - Crack, Gap - Medium / (R) Front Door, Molding - Scratch - Small / (R) Rear Door, Molding - Scratch &amp; Dent - Minimal / Rear Bumper, Lamps, Panels - Scratch - Medium / Trunk Hood, Rear Gate - Repair mark - Yes / Trunk Hood, Rear Gate - Scratch &amp; Dent - Small / (L) Rear Fender, Molding - Scratch - Minimal / (L) Rear Door, Molding - Scratch - Small / (L) Front Door, Molding - Scratch &amp; Dent - Medium / (L) Front Fender, Molding - Repair mark - Yes / (L) Front Fender, Molding - Scratch &amp; Dent - Medium / Front Bumper, Grille, Lamps - Repair mark - Yes / Front Bumper, Grille, Lamps - Scratch - Small / Bonnet, Headlight - Scratch &amp; Dent - Small / Roof - Scratch - Minimal / Overall Exterior - Worn as per age - Yes</div></div> |
