## General Information

| Make | Toyota | Model | Vios |

## Body / Panel Condition

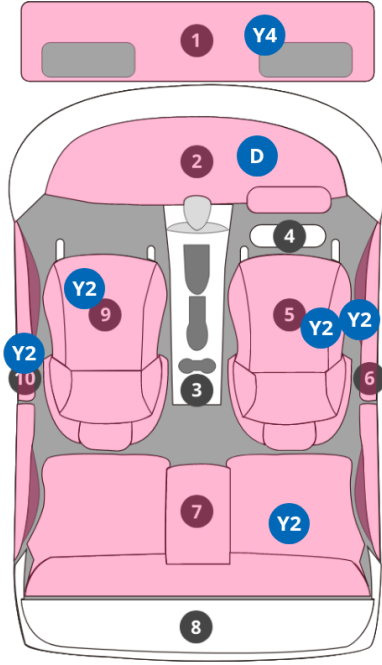
| Interior Evaluation : <span style="color: red;">C</span> | Exterior Evaluation : <span style="color: red;">C</span> |
| <p><b>Remarks</b><br/>Ceiling - Grime - Large / (R) Front Trim - Grime - Small / Rear Seat - Grime - Small / (L) Front Seat - Grime - Small / (L) Front Trim - Grime - Small / (R) Front Seat - Grime - Small / Dashboard - Traces of Adhesive Tape - Yes</p> | <p><b>Remarks</b><br/>(R) Front Door - Repair Traces - Yes / (R) Step - Repair Traces - Yes / (L) Front Fender - Repair Traces - Yes / (L) Step - Repair Traces - Yes / Trunk Hood, Rear Gate - Repair Traces - Yes / Roof - Repair Traces - Yes / Trunk Hood, Rear Gate - Modified - Medium / (R) Front Door, Molding - Scratch - Small / (L) Front Door, Molding - Scratch - Small / (R) Rear Door, Molding - Dent - Small / (R) Rear Fender, Molding - Scratch &amp; Dent - Medium / (L) Rear Door, Molding - Scratch - Small / Bonnet, Headlight - Scratch &amp; Dent - Small / Front Bumper, Grille, Lamps - Scratch &amp; Dent - Small</p> |

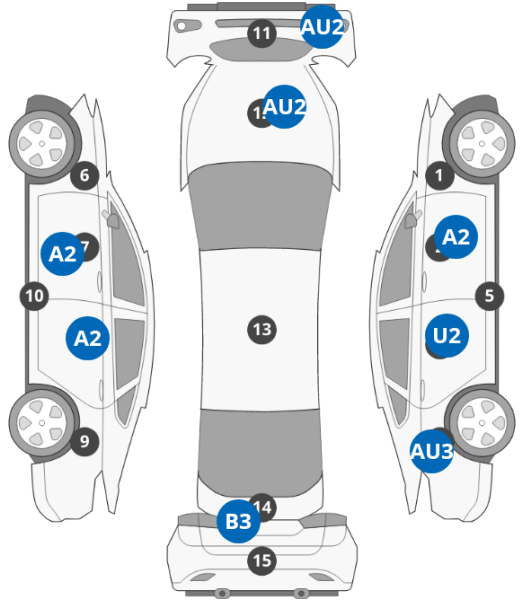
Left an right side mirror not working. rear right passenger seatbelt not working. roof repainted. 3 tire no hub cap. headlight not working. No spare tire. No Jack and tools. with spare key. no seat cover
