## General Information

| Make | Toyota | Model | Vios |

## Body / Panel Condition

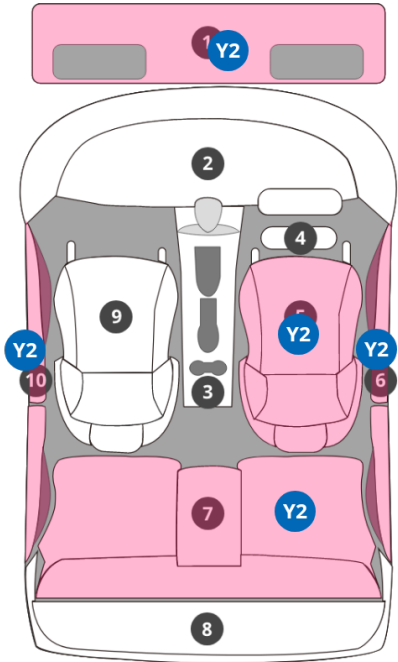
| Interior Evaluation : <b>B</b> | Exterior Evaluation : <b>E</b> |
| <b>Remarks</b><br>(R) Front Trim - Grime - Small / (R) Front Seat - Grime - Small / Rear Seat - Grime - Small / Ceiling - Grime - Small / (L) Front Trim - Grime - Small | <b>Remarks</b><br>(R) Front Door - Repair Traces - Yes / (R) Step - Repair Traces - Yes / (R) Front Fender - Repair Traces - Yes / Bonnet - Repair Traces - Yes / (L) Front Fender - Repair Traces - Yes / (L) Step - Repair Traces - Yes / (R) Rear Fender - Repair Traces - Yes / (R) Rear Door - Repair Traces - Yes / (R) Front Door, Molding - Dent - Large / (R) Rear Door, Molding - Dent - Large / Trunk Hood, Rear Gate - Scratch - Small / (L) Rear Fender, Molding - Scratch - Medium / (L) Rear Door, Molding - Scratch - Large / (L) Front Door, Molding - Scratch & Dent - Large / (L) Front Fender, Molding - Scratch & Dent - Large / Front Bumper, Grille, Lamps - Crack, Gap - Large / Bonnet, Headlight - Scratch - Medium |
