## General Information

| Make | Toyota | Model | Wigo |
| YOM | 2025 | Odo Meter Reading | 20,424 |
| Registration No. | GBF7807 | Chassis No. | MHKAA1BC1RJ030278 |

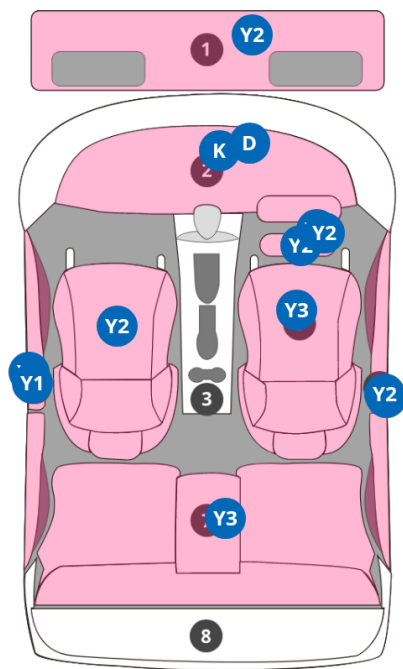
| <div> </div> <div> <div>a : Cut, Fray d : Loose, Deformed k : Animal Hair s : Smell t : Cigarette Burns x : Defective y : Stain</div> </div> | <div> </div> <div> <div>A : Scratch AU : Scratch &amp; Dent B : Modified C : Corrosion G : Stone chip P : Faded S : Rust SC : Rust &amp; Corrosion U : Dent X : Defective Y : Crack, Gap</div> </div> |
| <div> <div>Remarks</div> <div>(R) Front Seat - Grime - Medium / (L) Front Floor Mat - Grime - Small / (R) Front Floor Mat - Grime - Small / (R) Front Trim - Grime - Small / (R) Rear Trim - Grime - Small / Overall Interior - Animal Hair - Yes / (L) Front Trim - Grime - Small / (L) Front Seat - Grime - Small / Ceiling - Grime - Small / (L) Rear Trim - Grime - Minimal / Rear Seat - Grime - Medium / Mat Other - Grime - Small / Dashboard - Traces of Adhesive Tape - Yes</div> </div> | <div> <div>Remarks</div> <div>Front Bumper, Grille, Lamps - Scratch &amp; Dent - Large / (R) Front Fender, Molding - Scratch &amp; Dent - Large / (R) Front Door, Molding - Scratch - Large / (R) Mirror - Scratch - Minimal / (R) Step, In-panel, Side Spoiler - Scratch - Small / (R) Rear Door, Molding - Scratch - Medium / (R) Rear Fender, Molding - Scratch - Medium / Rear Bumper, Lamps, Panels - Scratch - Medium / Trunk Hood, Rear Gate - Scratch - Small / (L) Rear Fender, Molding - Scratch - Medium / (L) Rear Door, Molding - Scratch - Medium / (L) Step, In-panel, Side Spoiler - Scratch &amp; Dent - Large / (L) Front Door, Molding - Scratch - Medium / (L) Mirror - Scratch - Small / Bonnet, Headlight - Scratch - Minimal / (L) Front Fender, Molding - Scratch - Small</div> </div> |
