## General Information

| Make | Toyota | Model | Vios |
| Registration No. | EAL2776 | Chassis No. | PA1B18F3XS4290317 |

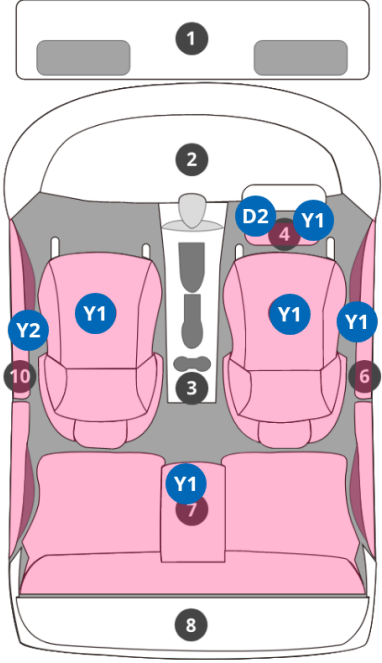
| <b>Interior Evaluation :</b> <span style="color: red; font-weight: bold;">A</span> | <b>Exterior Evaluation :</b> <span style="color: red; font-weight: bold;">C</span> |
| <b>Remarks</b><br>Rear Seat - Grime - Minimal / (R) Front Trim - Grime - Minimal / (R) Front Floor Mat - Grime - Minimal / (L) Front Trim - Grime - Small / (L) Front Floor Mat - Worked - Small / (R) Front Seat - Grime - Minimal / (L) Front Seat - Grime - Minimal | <b>Remarks</b><br>(L) Front Fender, Molding - Scratch - Minimal / (L) Front Door, Molding - Scratch - Small / (L) Step, In-panel, Side Spoiler - Scratch - Minimal / (L) Rear Door, Molding - Scratch - Small / (L) Rear Fender, Molding - Scratch - Minimal / Trunk Hood, Rear Gate - Scratch - Small / Rear Bumper, Lamps, Panels - Scratch - Minimal / (R) Rear Fender, Molding - Scratch - Small / (R) Rear Door, Molding - Scratch - Small / (R) Step, In-panel, Side Spoiler - Scratch - Small / (R) Front Door, Molding - Scratch & Dent - Small / (L) Mirror - Scratch - Minimal / (R) Front Fender, Molding - Scratch & Dent - Small / Front Bumper, Grille, Lamps - Scratch - Medium / Bonnet, Headlight - Scratch - Small / Roof - Scratch - Small |

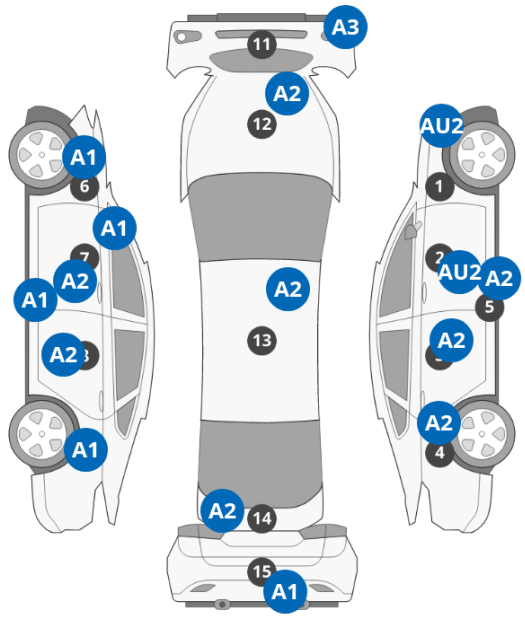
with LTO plate/with warranty booklet/with incomplete tools with jack/with spare tire/hairline scratches on the body
