## General Information

| Make | Toyota | Model | Avanza |
| YOM | 2025 | Odo Meter Reading | 18,803 |
| Registration No. | NJJ1144 | Chassis No. | MHFAA1BY3S0046794 |

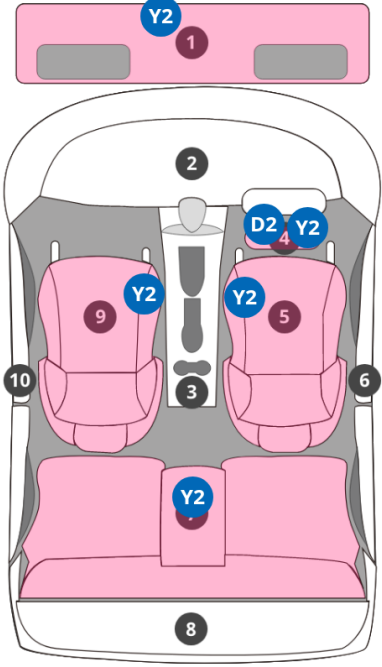
| Interior Evaluation : <b>B</b> | Exterior Evaluation : <b>D</b> |
|---|---|
| <b>Remarks</b><br>Ceiling - Grime - Small / (L) Front Floor Mat - Worked - Small / (R) Front Seat - Grime - Small / (R) Front Floor Mat - Grime - Small / Rear Seat - Grime - Small / (L) Front Seat - Grime - Small | <b>Remarks</b><br>(L) Front Fender - Repair Traces - Yes / (R) Front Fender, Molding - Scratch - Minimal / (R) Mirror - Scratch - Minimal / (R) Front Door, Molding - Scratch - Minimal / (R) Rear Door, Molding - Scratch - Small / (R) Rear Fender, Molding - Scratch & Dent - Medium / Rear Bumper, Lamps, Panels - Scratch & Dent - Large / Trunk Hood, Rear Gate - Scratch - Minimal / (L) Rear Fender, Molding - Scratch - Minimal / (L) Front Door, Molding - Scratch - Small / (L) Rear Door, Molding - Scratch - Small / (L) Mirror - Scratch - Small / (L) Front Fender, Molding - Scratch - Small / Front Bumper, Grille, Lamps - Scratch & Dent - Large / Bonnet, Headlight - Crack, Gap - Medium / Roof - Scratch - Minimal |
