## General Information

| Make | Toyota | Model | Vios |

## Body / Panel Condition

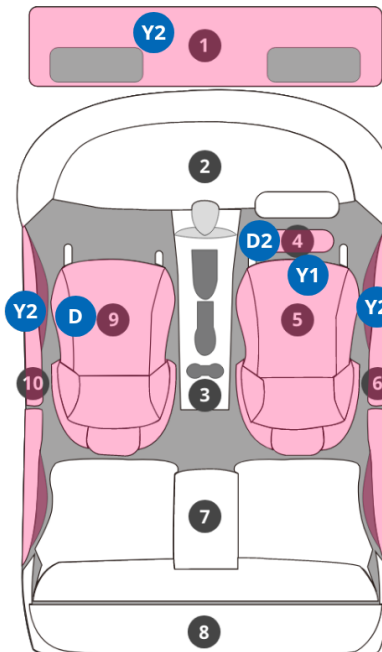
| Interior Evaluation : <b>B</b> | Exterior Evaluation : <b>D</b> |
| <p><b>Remarks</b></p> <p>Ceiling - Grime - Small / (L) Front Floor Mat - Worked - Small / (L) Front Seat - Worn - Yes / (L) Front Trim - Grime - Small / (R) Front Trim - Grime - Small / (R) Front Seat - Grime - Minimal</p> | <p><b>Remarks</b></p> <p>Trunk Hood, Rear Gate - Repair Traces - Yes / Rear Bumper, Lamps, Panels - Repair mark - Yes / (R) Front Fender, Molding - Scratch - Minimal / (R) Mirror - Scratch - Minimal / (R) Front Door, Molding - Scratch - Small / (R) Rear Door, Molding - Scratch - Small / (R) Rear Fender, Molding - Scratch - Small / Rear Bumper, Lamps, Panels - Scratch - Small / Trunk Hood, Rear Gate - Scratch - Small / (L) Rear Fender, Molding - Scratch - Minimal / (L) Rear Door, Molding - Scratch - Small / (L) Front Door, Molding - Scratch - Minimal / (L) Mirror - Scratch - Minimal / Front Bumper, Grille, Lamps - Scratch - Medium / Bonnet, Headlight - Scratch - Small / Overall Exterior - Faded(Color, Gloss) - Yes / Overall Exterior - Full Re-Paint in same color - Yes / Roof - Scratch &amp; Dent - Medium / (L) Rear Fender, Molding - Repair mark - Yes / (R) Rear Fender, Molding - Repair mark - Yes</p> |
