## General Information

| Make | Toyota | Model | Vios |

## Body / Panel Condition

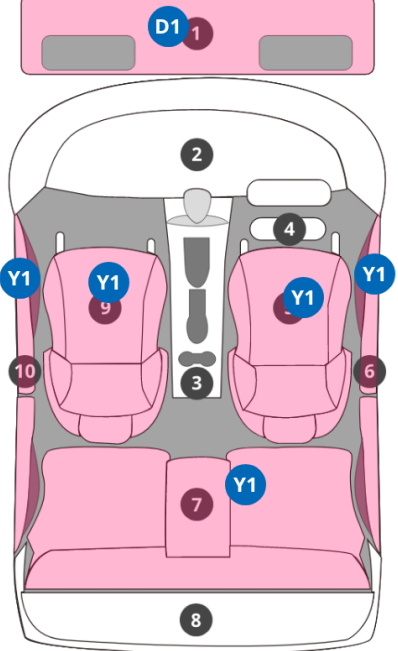
| Interior Evaluation : <b>A</b> | Exterior Evaluation : <b>E</b> |
|---|---|
| <b>Remarks</b><br>(L) Front Seat - Grime - Minimal / (R) Front Seat - Grime - Minimal / Rear Seat - Grime - Minimal / (L) Front Trim - Grime - Minimal / (R) Front Trim - Grime - Minimal / Ceiling - Crinkle - Minimal | <b>Remarks</b><br>(R) Front Fender - Repair Traces - Yes / Bonnet - Repair Traces - Yes / (L) Front Fender - Repair Traces - Yes / Trunk Hood, Rear Gate - Scratch & Dent - Small / Rear Bumper, Lamps, Panels - Scratch - Large / (L) Rear Fender, Molding - Scratch & Dent - Small / (L) Step, In-panel, Side Spoiler - Scratch & Dent - Large / (L) Rear Door, Molding - Scratch & Dent - Small / (L) Front Door, Molding - Scratch - Small / Roof - Scratch - Medium / (L) Front Fender, Molding - Scratch - Small / Front Bumper, Grille, Lamps - Scratch - Medium / Bonnet, Headlight - Scratch - Medium / (R) Front Fender, Molding - Scratch & Dent - Small / (R) Front Door, Molding - Scratch & Dent - Small / (R) Rear Door, Molding - Scratch & Dent - Small / (R) Rear Fender, Molding - Scratch & Dent - Minimal |

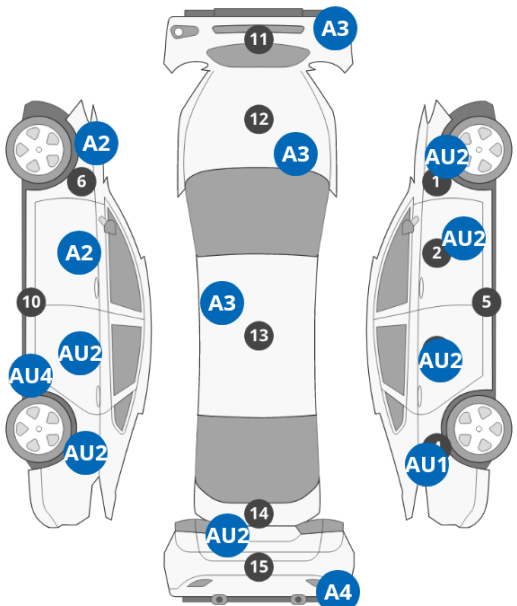
with LTO plate, with spare key, with jack, with reverse camera, no spare tire, no tools, no warranty and manual booklet, scratches and dent on exterior, left and right front side mat missing, scratches on taillight and headlight.
