## General Information

| Make | Toyota | Model | Vios |
| YOM | 2023 | Odo Meter Reading | 148,877 |
| Registration No. | DBG7646 | Chassis No. | PA1B18F35P4202491 |

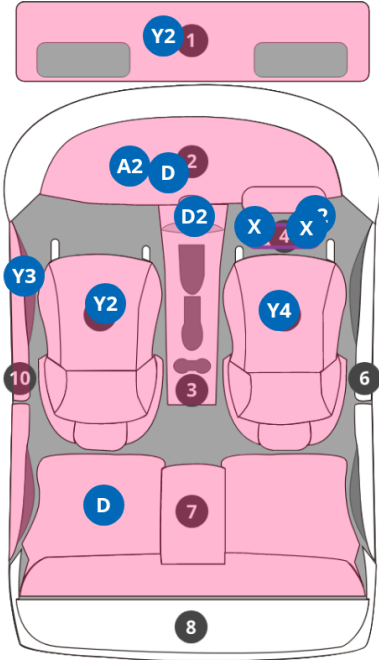
| Interior Evaluation : <b>C</b> | Exterior Evaluation : <b>E</b> |
|---|---|
| <p><b>Remarks</b></p> <p>Dashboard - Traces of Adhesive Tape - Yes / Console, Switches, Vents - Loose, Deformed - Small / (R) Front Floor Mat - Loose, Deformed - Small / (L) Front Floor Mat - Missing - Yes / (R) Front Seat - Grime - Large / (L) Front Trim - Grime - Medium / Rear Seat - Repair Mark - Yes / (L) Front Seat - Grime - Small / Ceiling - Grime - Small / Steering Wheel - Worn, Peel, Crack - Small / Mat Other - Missing - Yes</p> | <p><b>Remarks</b></p> <p>(R) Front Door - Repair Traces - Yes / (R) Step - Replaced - Yes / (R) Step - Repair Traces - Yes / (R) Front Fender - Repair Traces - Yes / (L) Front Fender - Repair Traces - Yes / (L) Rear Door - Repair Traces - Yes / (L) Rear Fender - Repair Traces - Yes / Trunk Hood, Rear Gate - Repair Traces - Yes / (R) Front Fender, Molding - Repair mark - Yes / (R) Mirror - Crack - Damaged / (R) Front Door, Molding - Scratch &amp; Dent - Small / (R) Rear Door, Molding - Scratch - Small / (R) Rear Fender, Molding - Scratch &amp; Dent - Medium / (R) Step, In-panel, Side Spoiler - Scratch - Minimal / Rear Bumper, Lamps, Panels - Modified - Small / Trunk Hood, Rear Gate - Crack, Gap - Large / (L) Rear Fender, Molding - Repair mark - Yes / (L) Rear Door, Molding - Scratch &amp; Dent - Medium / (L) Step, In-panel, Side Spoiler - Scratch &amp; Dent - Large / (L) Mirror - Crack - Damaged / Roof - Dent - Small / Front Bumper, Grille, Lamps - Repair mark - Yes / (L) Front Fender, Molding - Repair mark - Difference in Color / Bonnet, Headlight - Scratch - Small</p> |
