## General Information

| Make | Toyota | Model | Vios |
| YOM | 2025 | Odo Meter Reading | 8,254 |

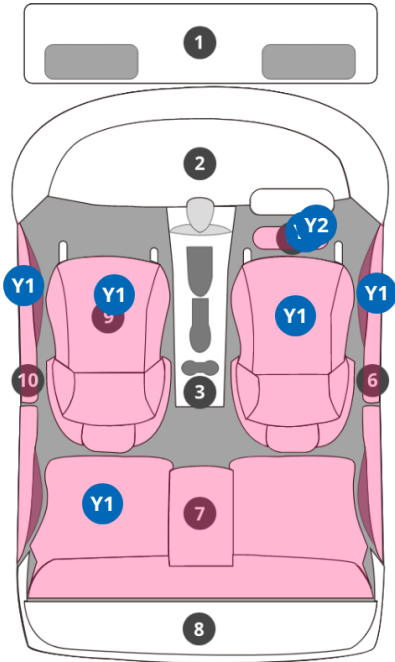
| Interior Evaluation : <b>A</b> | Exterior Evaluation : <b>C</b> |
|---|---|
| <b>Remarks</b><br>(L) Front Floor Mat - Grime - Small / (R) Front Floor Mat - Grime - Small / (L) Front Seat - Grime - Minimal / (R) Front Seat - Grime - Minimal / Rear Seat - Grime - Minimal / (L) Front Trim - Grime - Minimal / (R) Front Trim - Grime - Minimal | <b>Remarks</b><br>(R) Front Fender - Repair Traces - Yes / (L) Front Fender - Repair Traces - Yes / (R) Rear Fender, Molding - Scratch - Small / (R) Front Fender, Molding - Scratch - Small / Bonnet, Headlight - Scratch - Medium / Front Bumper, Grille, Lamps - Scratch - Medium / Rear Bumper, Lamps, Panels - Scratch - Small / (L) Rear Fender, Molding - Scratch & Dent - Minimal / (L) Rear Door, Molding - Scratch & Dent - Minimal / (L) Step, In-panel, Side Spoiler - Scratch & Dent - Medium / Roof - Scratch - Minimal / (L) Front Door, Molding - Scratch & Dent - Medium / (R) Rear Door, Molding - Scratch - Minimal / (R) Front Door, Molding - Scratch - Minimal / Trunk Hood, Rear Gate - Scratch - Minimal / (L) Front Fender, Molding - Scratch - Minimal |

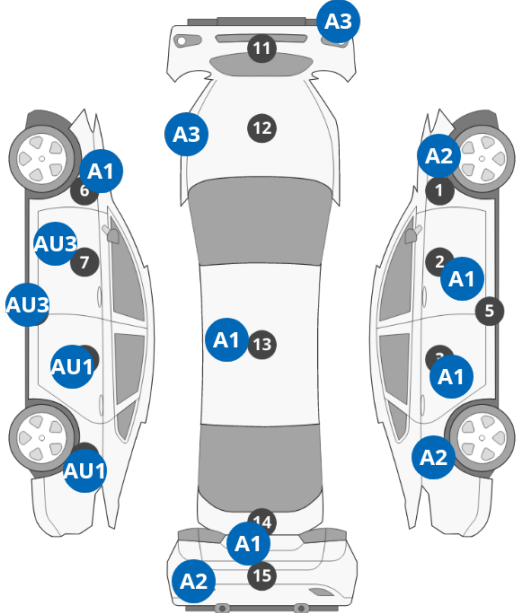
| Inspector Notes |
|---|
| with LTO plate, with jack, with reverse camera, with spare tire, no tools, no warranty and manual booklet, no spare key, scratches and dent on exterior , scratches on taillight and headlight |
