## General Information

| Make | Toyota | Model | Vios |

## Body / Panel Condition

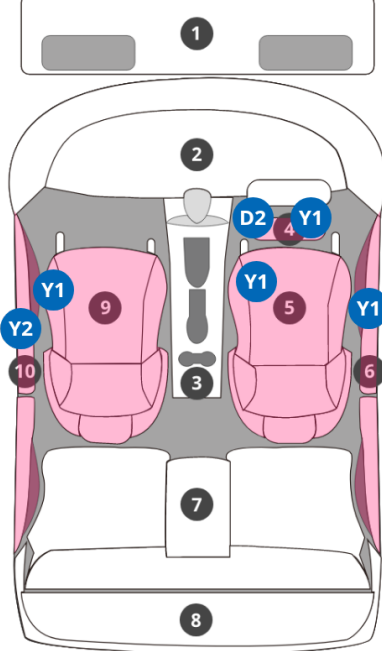
| Interior Evaluation : <span style="color: red; font-weight: bold;">A</span> | Exterior Evaluation : <span style="color: red; font-weight: bold;">C</span> |
| <b>Remarks</b><br>(R) Front Trim - Grime - Minimal / (R) Front Floor Mat - Grime - Minimal / (L) Front Trim - Grime - Small / (L) Front Seat - Grime - Minimal / (L) Front Floor Mat - Worked - Small / (R) Front Seat - Grime - Minimal | <b>Remarks</b><br>(L) Front Fender, Molding - Scratch - Minimal / (L) Front Door, Molding - Scratch - Small / (L) Rear Door, Molding - Scratch - Small / (L) Step, In-panel, Side Spoiler - Scratch - Minimal / Trunk Hood, Rear Gate - Scratch & Dent - Minimal / Rear Bumper, Lamps, Panels - Scratch - Small / (R) Rear Fender, Molding - Scratch - Small / (R) Rear Door, Molding - Scratch - Small / (R) Step, In-panel, Side Spoiler - Scratch - Small / (R) Front Door, Molding - Scratch - Small / (R) Mirror - Scratch - Small / (R) Front Fender, Molding - Scratch - Minimal / Front Bumper, Grille, Lamps - Scratch - Small / Bonnet, Headlight - Scratch - Minimal / Roof - Scratch - Minimal |

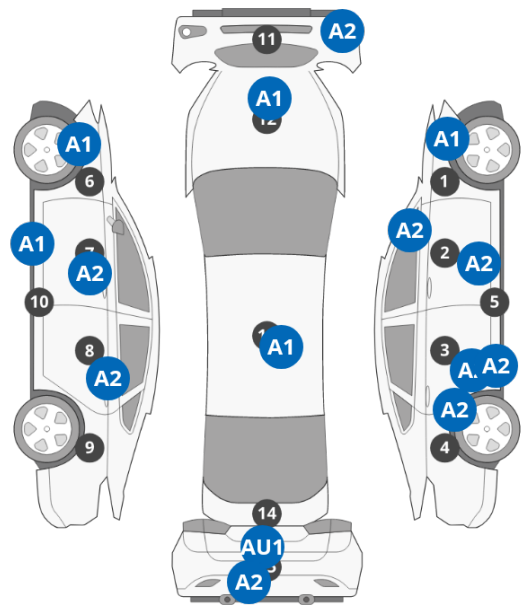
with LTO plate/with warranty booklet/with incomplete tools with jack/with spare tire/hairline scratches on the body
