## General Information

| Make | Toyota | Model | Vios |
| Registration No. | EAJ6358 | Chassis No. | PA1B18F35R4266226 |

## Body / Panel Condition

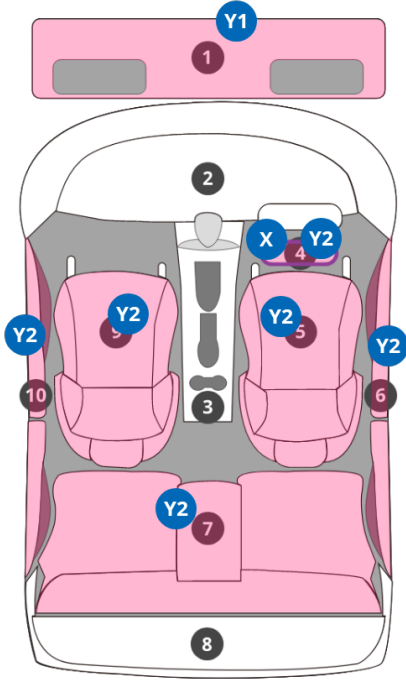
| Interior Evaluation : <b>B</b> | Exterior Evaluation : <b>E</b> |
| <p><b>Remarks</b></p> <p>(R) Front Trim - Grime - Small / (R) Front Seat - Grime - Small / (R) Front Floor Mat - Grime - Small / Rear Seat - Grime - Small / (L) Front Trim - Grime - Small / (L) Front Floor Mat - Missing - Yes / (L) Front Seat - Grime - Small / Ceiling - Grime - Minimal</p> | <p><b>Remarks</b></p> <p>(R) Front Door - Repair Traces - Yes / (R) Front Fender - Repair Traces - Yes / Bonnet - Repair Traces - Yes / (L) Front Fender - Repair Traces - Yes / (L) Front Door - Repair Traces - Yes / (L) Step - Repair Traces - Yes / (L) Rear Door - Repair Traces - Yes / (L) Rear Fender - Repair Traces - Yes / Trunk Hood, Rear Gate - Repair Traces - Yes / (R) Rear Fender - Repair Traces - Yes / (R) Rear Door - Repair Traces - Yes / Roof - Repair Traces - Yes / (L) Front Fender, Molding - Repair mark - Yes / (L) Front Door, Molding - Repair mark - Yes / (L) Rear Door, Molding - Repair mark - Yes / (L) Step, In-panel, Side Spoiler - Repair mark - Yes / (L) Rear Fender, Molding - Repair mark - Yes / (L) Front Fender, Molding - Scratch &amp; Dent - Small / (L) Front Door, Molding - Scratch - Small / (L) Step, In-panel, Side Spoiler - Scratch &amp; Dent - Large / (L) Rear Door, Molding - Scratch - Small / (L) Rear Fender, Molding - Scratch - Small / Rear Bumper, Lamps, Panels - Scratch - Medium / Trunk Hood, Rear Gate - Scratch - Small / (R) Rear Fender, Molding - Scratch - Small / (R) Rear Door, Molding - Scratch &amp; Dent - Small / (R) Front Door, Molding - Scratch &amp; Dent - Small / (R) Step, In-panel, Side Spoiler - Scratch &amp; Dent - Large / (R) Front Fender, Molding - Crack, Gap - Large / Front Bumper, Grille, Lamps - Scratch - Large / Bonnet, Headlight - Scratch - Small / Roof - Scratch - Minimal</p> |
