## General Information

| Make | Toyota | Model | Raize |
| YOM | 2023 | Odo Meter Reading | 59,467 |
| Registration No. | NEE2629 | Chassis No. | MHKAB1BA6NJ030833 |

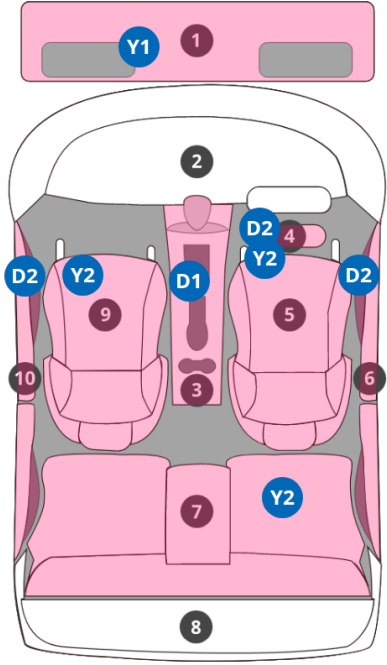
| Interior Evaluation : <b>B</b> | Exterior Evaluation : <b>B</b> |
|---|---|
| <p><b>Remarks</b><br/>Ceiling - Grime - Minimal / (L) Front Seat - Grime - Small / (R) Front Floor Mat - Worked - Small / (R) Front Seat - Grime - Small / Rear Seat - Grime - Small / (R) Front Trim - Worked - Small / (L) Front Trim - Worked - Small / Console, Switchs, Vents - Worked - Minimal</p> | <p><b>Remarks</b><br/>(R) Front Fender, Molding - Scratch - Minimal / (R) Front Door, Molding - Scratch - Small / (R) Mirror - Scratch - Minimal / (R) Step, In-panel, Side Spoiler - Scratch - Minimal / (R) Rear Door, Molding - Scratch - Minimal / (R) Rear Fender, Molding - Scratch - Minimal / Trunk Hood, Rear Gate - Scratch - Minimal / (L) Rear Fender, Molding - Scratch - Minimal / (L) Rear Door, Molding - Scratch - Minimal / Roof - Scratch - Minimal / (L) Front Door, Molding - Scratch - Minimal / (L) Front Fender, Molding - Scratch - Minimal / Bonnet, Headlight - Scratch - Minimal</p> |
