## General Information

| Make | Toyota | Model | Vios |
| Registration No. | NEK6060 | Chassis No. | PA1B18F37S4287861 |

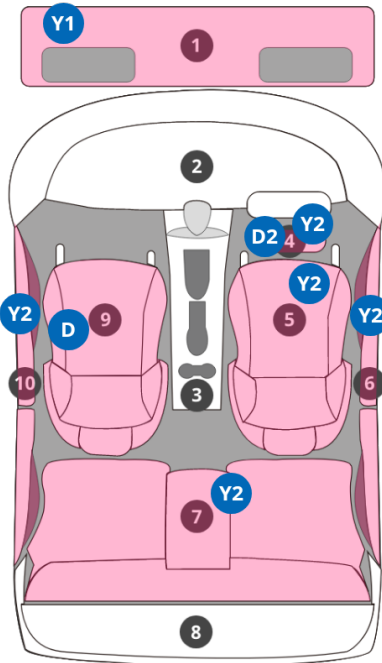
| <b>Interior Evaluation :</b> <b>B</b> | <b>Exterior Evaluation :</b> <b>D</b> |
| <b>Remarks</b><br>(L) Front Seat - Worn - Yes / (L) Front Floor Mat - Worked - Small / (R) Front Floor Mat - Grime - Small / Ceiling - Grime - Minimal / (L) Front Trim - Grime - Small / (R) Front Trim - Grime - Small / (R) Front Seat - Grime - Small / Rear Seat - Grime - Small | <b>Remarks</b><br>(R) Rear Fender - Repair Traces - Yes / (R) Front Fender, Molding - Scratch - Small / (R) Front Door, Molding - Scratch & Dent - Medium / (R) Rear Door, Molding - Scratch & Dent - Large / (R) Rear Fender, Molding - Scratch & Dent - Medium / Rear Bumper, Lamps, Panels - Repair mark - Yes / Rear Bumper, Lamps, Panels - Dent - Minimal / Trunk Hood, Rear Gate - Scratch - Minimal / (L) Rear Fender, Molding - Scratch & Dent - Minimal / (L) Rear Door, Molding - Scratch - Medium / (L) Front Door, Molding - Scratch - Small / (L) Mirror - Scratch - Small / (L) Front Fender, Molding - Dent - Medium / Front Bumper, Grille, Lamps - Scratch & Dent - Small / Bonnet, Headlight - Scratch - Minimal / Roof - Scratch - Minimal |

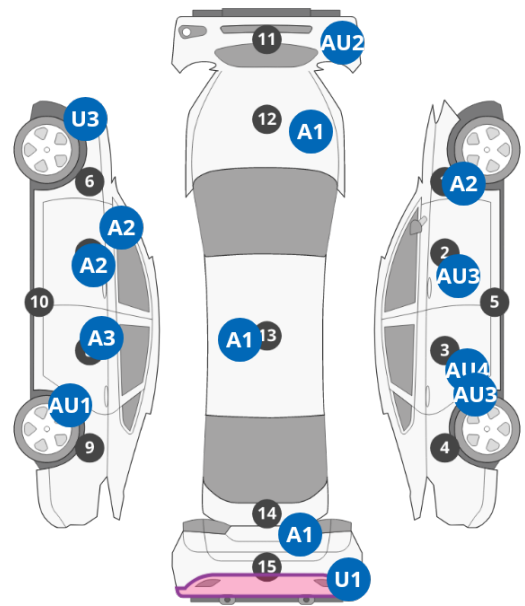
| Inspector Notes |
|---|
| with warranty booklet, no jack and tools, with spare tire, with LTO plate, scratches on tail light |
