## General Information

| Make | Toyota | Model | Avanza |

## Body / Panel Condition

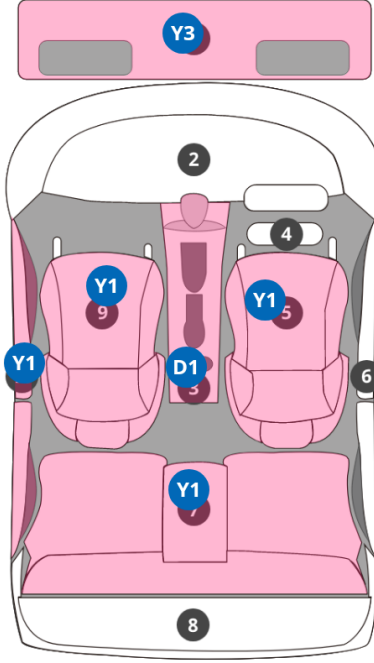
| Interior Evaluation : <span style="color: red; font-weight: bold;">B</span> | | Exterior Evaluation : <span style="color: red; font-weight: bold;">E</span> | |
| <p><b>Remarks</b></p> <p>Console, Switchs, Vents - Loose, Deformed - Minimal / (R) Front Seat - Grime - Minimal / (L) Front Seat - Grime - Minimal / Rear Seat - Grime - Minimal / Ceiling - Grime - Medium / (L) Front Trim - Grime - Minimal</p> | | <p><b>Remarks</b></p> <p>(R) Front Fender, Molding - Scratch - Small / (R) Mirror - Scratch - Minimal / (R) Front Door, Molding - Scratch - Medium / (R) Step, In-panel, Side Spoiler - Scratch &amp; Dent - Medium / (R) Rear Door, Molding - Scratch - Small / (R) Rear Fender, Molding - Scratch - Medium / (L) Front Fender, Molding - Scratch - Medium / (L) Front Door, Molding - Scratch - Medium / (L) Rear Door, Molding - Scratch - Small / (L) Rear Fender, Molding - Scratch - Small / (L) Step, In-panel, Side Spoiler - Scratch &amp; Dent - Large / Front Bumper, Grille, Lamps - Scratch - Medium / Bonnet, Headlight - Scratch - Minimal / Trunk Hood, Rear Gate - Scratch - Minimal / Rear Bumper, Lamps, Panels - Scratch - Medium</p> | |
