## General Information

| Make | Toyota | Model | Raize |
| YOM | 2022 | Odo Meter Reading | 38,375 |

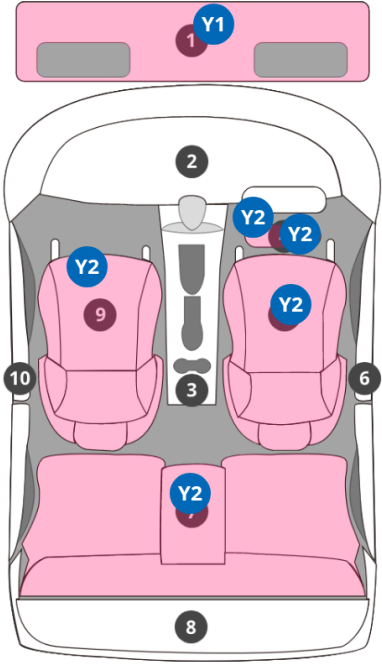
| Interior Evaluation : <b>B</b> | Exterior Evaluation : <b>D</b> |
| <p><b>Remarks</b><br/>(R) Front Seat - Grime - Small / (R) Front Floor Mat - Grime - Small / Rear Seat - Grime - Small / (L) Front Floor Mat - Grime - Small / (L) Front Seat - Grime - Small / Ceiling - Grime - Minimal</p> | <p><b>Remarks</b><br/>(L) Mirror - Scratch - Minimal / (L) Front Fender, Molding - Scratch - Minimal / (L) Step, In-panel, Side Spoiler - Scratch - Small / (L) Front Door, Molding - Scratch - Small / (L) Rear Door, Molding - Scratch - Small / (L) Rear Fender, Molding - Scratch - Minimal / Rear Bumper, Lamps, Panels - Scratch - Medium / Trunk Hood, Rear Gate - Scratch - Small / (R) Rear Fender, Molding - Scratch - Minimal / (R) Rear Door, Molding - Scratch &amp; Dent - Large / (R) Step, In-panel, Side Spoiler - Scratch - Large / (R) Mirror - Scratch - Minimal / (R) Front Door, Molding - Scratch &amp; Dent - Small / (R) Front Fender, Molding - Scratch - Minimal / Bonnet, Headlight - Scratch &amp; Dent - Small / Front Bumper, Grille, Lamps - Crack, Gap - Medium / Roof - Scratch - Minimal</p> |
