## General Information

| Make | Toyota | Model | Vios |
| Registration No. | NFR9434 | Chassis No. | PA1B18F36R4256577 |

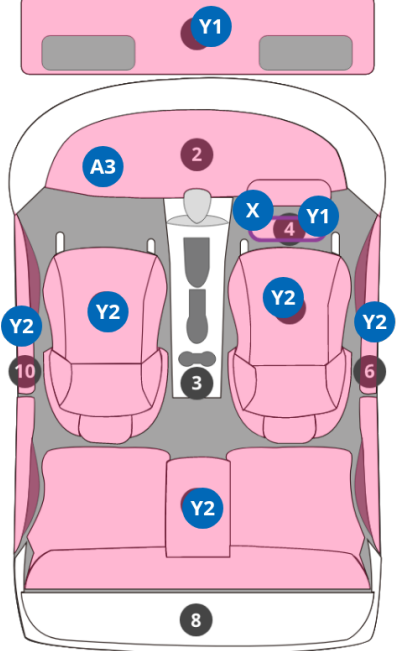
| Interior Evaluation : <b>B</b> | Exterior Evaluation : <b>C</b> |
| <p><b>Remarks</b></p> <p>(R) Front Trim - Grime - Small / (R) Front Seat - Grime - Small / (R) Front Floor Mat - Grime - Minimal / Rear Seat - Grime - Small / (L) Front Trim - Grime - Small / (L) Front Floor Mat - Missing - Yes / Ceiling - Grime - Minimal / (L) Front Seat - Grime - Small / Instrument Panel - Worn, Scratch, Cut, Crack - Medium</p> | <p><b>Remarks</b></p> <p>(L) Front Fender, Molding - Scratch - Small / Bonnet, Headlight - Scratch - Minimal / Front Bumper, Grille, Lamps - Scratch - Small / (L) Mirror - Scratch - Minimal / (L) Front Door, Molding - Scratch &amp; Dent - Small / (L) Step, In-panel, Side Spoiler - Scratch - Minimal / (L) Rear Door, Molding - Scratch - Small / (L) Rear Fender, Molding - Scratch - Small / Trunk Hood, Rear Gate - Scratch - Small / Rear Bumper, Lamps, Panels - Scratch - Small / (R) Rear Fender, Molding - Scratch - Small / (R) Rear Door, Molding - Scratch - Small / (R) Step, In-panel, Side Spoiler - Scratch - Small / (R) Front Door, Molding - Scratch - Small / (R) Mirror - Scratch - Minimal / (R) Front Fender, Molding - Scratch - Small / Roof - Scratch - Small</p> |

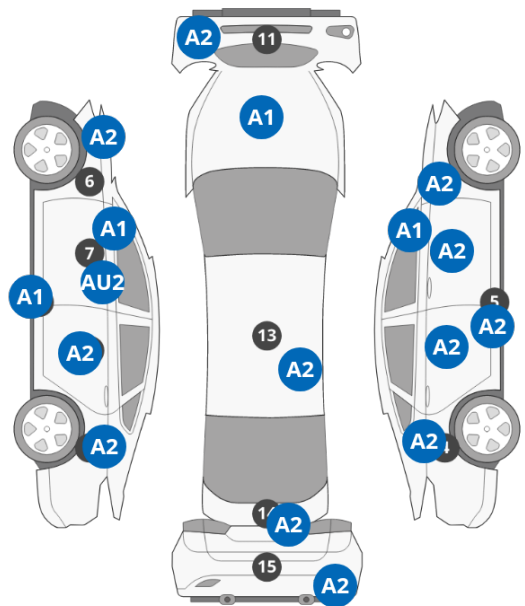
| Inspector Notes |
|---|
| without LTO plate/no warranty booklet/no tools and jack/with spare tire/rear seat belts missing/hairline scratches on the body |
