## General Information

| Make | Toyota | Model | Wigo |
| Registration No. | NJF7027 | Chassis No. | MHKAA1BC3SJ037660 |

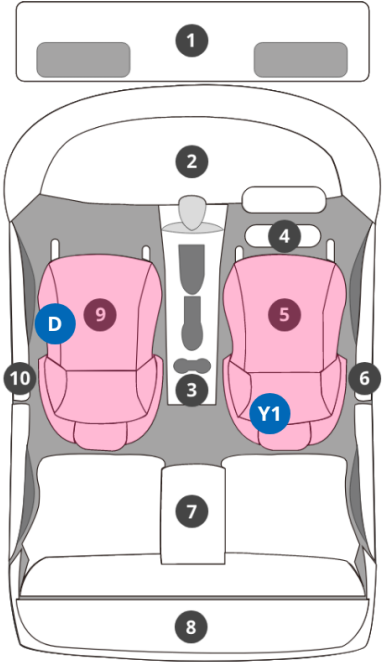
| Interior Evaluation : <b>B</b> | Exterior Evaluation : <b>E</b> |
|---|---|
| <b>Remarks</b><br>(L) Front Seat - Worn - Yes / (R) Front Seat - Grime - Minimal | <b>Remarks</b><br>(R) Front Fender, Molding - Scratch & Dent - Large / (R) Mirror - Scratch - Small / (R) Front Door, Molding - Scratch & Dent - Large / (R) Rear Door, Molding - Scratch - Medium / (R) Rear Fender, Molding - Scratch - Medium / Rear Bumper, Lamps, Panels - Scratch & Dent - Small / (L) Rear Fender, Molding - Scratch - Small / (L) Rear Door, Molding - Scratch & Dent - Medium / (L) Front Door, Molding - Scratch & Dent - Large / (L) Front Fender, Molding - Scratch & Dent - Large / (L) Step, In-panel, Side Spoiler - Scratch - Small / (L) Mirror - Scratch - Minimal / Front Bumper, Grille, Lamps - Crack, Gap - Medium / Bonnet, Headlight - Scratch - Medium / Roof - Scratch - Minimal / Trunk Hood, Rear Gate - Scratch - Small |

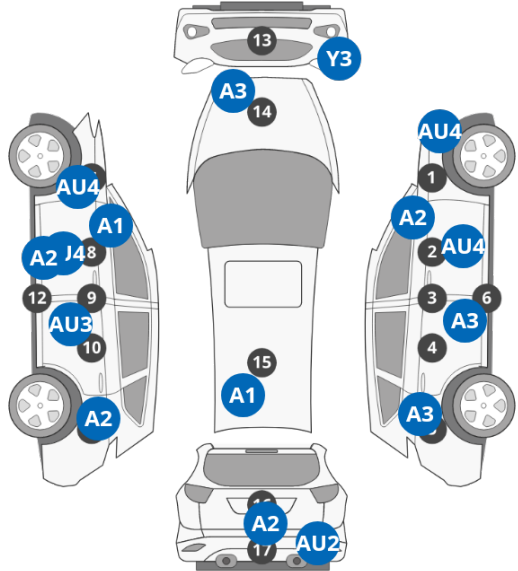
with warranty booklet, jack and tools, with spare tire, with LTO plate, scratches on tail light,
