## General Information

| Make | Toyota | Model | Vios |

## Body / Panel Condition

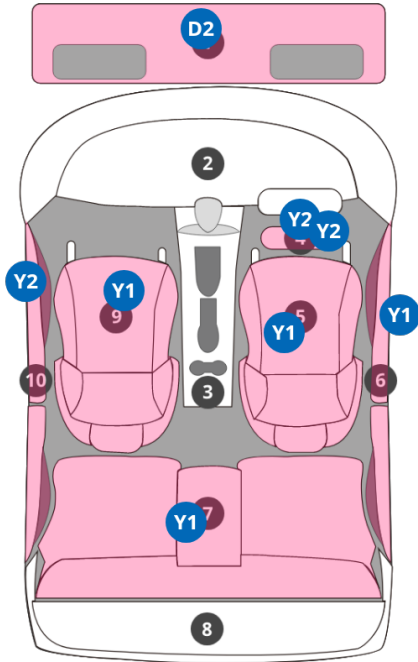
| Interior Evaluation : <span style="color: red;">B</span> | Exterior Evaluation : <span style="color: red;">C</span> |
| <b>Remarks</b><br>(L) Front Seat - Grime - Minimal / (R) Front Seat - Grime - Minimal / Rear Seat - Grime - Minimal / (L) Front Trim - Grime - Small / (R) Front Trim - Grime - Minimal / Ceiling - Crinkle - Small / (L) Front Floor Mat - Grime - Small / (R) Front Floor Mat - Grime - Small | <b>Remarks</b><br>Bonnet - Repair Traces - Yes / (L) Front Fender - Repair Traces - Yes / Trunk Hood, Rear Gate - Repair Traces - Yes / Roof - Scratch & Dent - Small / (L) Front Door, Molding - Scratch & Dent - Minimal / (L) Rear Fender, Molding - Scratch & Dent - Minimal / (L) Front Fender, Molding - Scratch & Dent - Minimal / Bonnet, Headlight - Scratch & Dent - Minimal / Front Bumper, Grille, Lamps - Scratch - Small / (R) Front Fender, Molding - Scratch & Dent - Minimal / (R) Front Door, Molding - Scratch - Medium / (R) Rear Door, Molding - Scratch - Medium / (R) Rear Fender, Molding - Dent - Medium / Rear Bumper, Lamps, Panels - Scratch - Small / Trunk Hood, Rear Gate - Scratch & Dent - Minimal / (L) Rear Door, Molding - Scratch & Dent - Minimal |

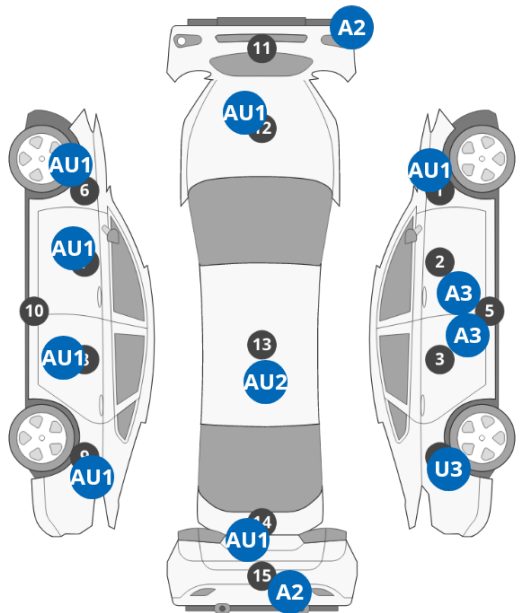
| Inspector Notes |
|---|
| with LTO plate, with spare tire, with jack, with reverse camera, with manual and warranty booklet, no tools, scratches and dent on exterior, scratches on taillight and headlight. |
