## General Information

| Make | Toyota | Model | Hilux Tamaraw |

## Body / Panel Condition

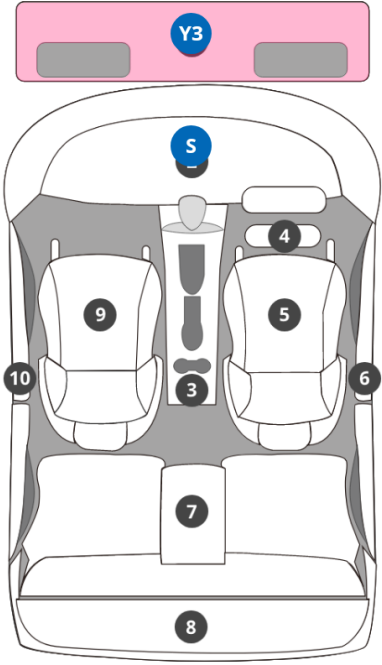
| Interior Evaluation : <b>B</b> | Exterior Evaluation : <b>E</b> |
|---|---|
| <p><b>Remarks</b><br/>Ceiling - Grime - Medium / Overall Interior - Smell - Yes</p> | <p><b>Remarks</b><br/>Bonnet - Repair Traces - Yes / (R) Front Fender, Molding - Scratch - Minimal / (R) Mirror - Scratch - Minimal / (R) Front Door, Molding - Scratch - Medium / (R) Rear Door, Molding - Scratch - Medium / (R) Rear Corner Panel - Scratch - Medium / (L) Front Fender, Molding - Scratch - Medium / (L) Mirror - Scratch - Minimal / (L) Front Door, Molding - Scratch - Medium / (L) Rear Door, Molding - Scratch - Small / (L) Rear Corner Panel - Scratch - Medium / Front Bumper, Grille, Lamps - Crack, Gap - Large / Bonnet, Headlight - Scratch - Minimal / Rear Bumper, Lamps, Panels - Scratch &amp; Dent - Medium / Rear Gate - Scratch - Minimal</p> |
