## General Information

| Make | Toyota | Model | Hilux |
| YOM | 2025 | Odo Meter Reading | 27,300 |

## Body / Panel Condition

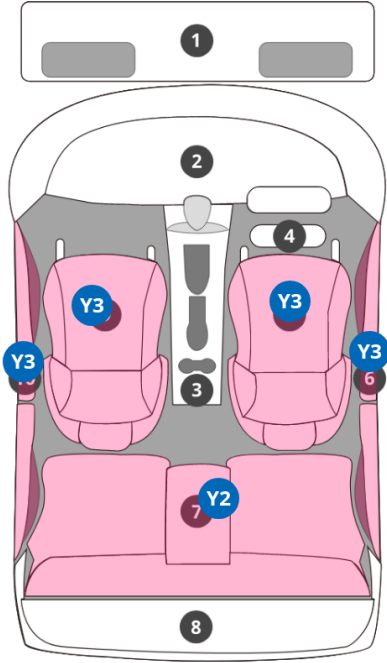
| Interior Evaluation : <b>B</b> | Exterior Evaluation : <b>B</b> |
| <b>Remarks</b><br>(L) Front Trim - Grime - Medium / (R) Front Seat - Grime - Medium / (L) Front Seat - Grime - Medium / Rear Seat - Grime - Small / (R) Front Trim - Grime - Medium | <b>Remarks</b><br>(R) Front Fender, Molding - Scratch - Small / (R) Front Door, Molding - Scratch - Small / (R) Rear Door, Molding - Dent - Minimal / (R) Side Gate - Scratch - Small / (L) Front Fender, Molding - Scratch - Minimal / (L) Front Door, Molding - Scratch - Minimal / (L) Rear Door, Molding - Modified - Small / (L) Side Gate - Scratch - Small / Front Bumper, Grille, Lamps - Scratch - Small / Bonnet, Headlight - Scratch - Small / Rear Gate - Scratch - Minimal / Rear Bumper, Lamps, Panels - Scratch - Minimal |
