## General Information

| Make | Toyota | Model | Wigo |
| YOM | 2021 | Odo Meter Reading | 51,971 |
| Registration No. | NEL3923 | Chassis No. | MHKA4DF5FMJ056771 |

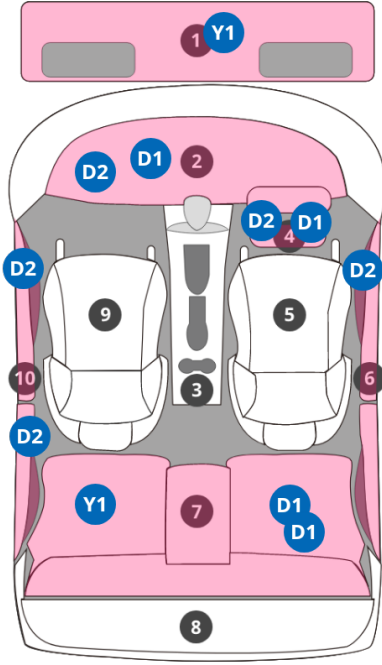
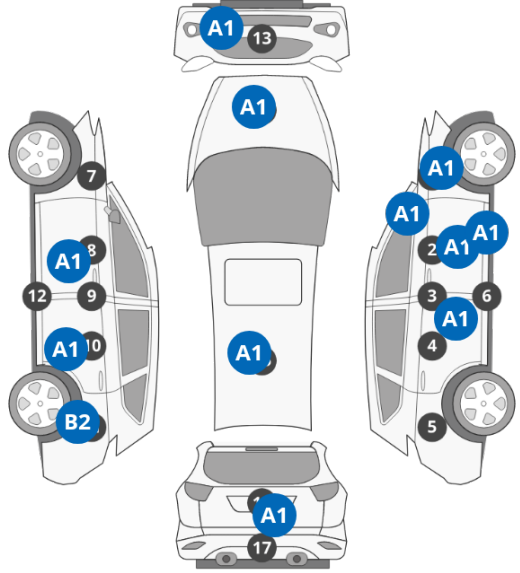
| Interior Evaluation : <b>B</b> | Exterior Evaluation : <b>B</b> |
|---|---|
| <p><b>a</b> : Cut, Fray <b>d</b> : Loose, Deformed <b>k</b> : Animal Hair <b>s</b> : Smell <b>t</b> : Cigarette Burns <b>x</b> : Defective <b>y</b> : Stain</p> | <p><b>A</b> : Scratch <b>AU</b> : Scratch &amp; Dent <b>B</b> : Modified <b>C</b> : Corrosion <b>G</b> : Stone chip <b>P</b> : Faded <b>S</b> : Rust <b>SC</b> : Rust &amp; Corrosion <b>U</b> : Dent <b>X</b> : Defective <b>Y</b> : Crack, Gap</p> |
| <b>Remarks</b><br>Ceiling - Grime - Minimal / Dashboard - Worked - Minimal / (L) Front Trim - Worked - Small / (R) Front Trim - Worked - Small / (L) Rear Trim - Worked - Small / Rear Seat - Grime - Minimal / Trim Other - Loose, Deformed - Minimal / Seat belt Other - Loose, Deformed - Minimal / (R) Front Floor Mat - Worked - Small / Carpet - Worked - Minimal / Dashboard - Loose, Deformed - Small | <b>Remarks</b><br>(L) Rear Door - Repair Traces - Yes / (R) Rear Fender - Repair Traces - Yes / (R) Rear Door - Repair Traces - Yes / (R) Front Fender, Molding - Scratch - Minimal / (R) Mirror - Scratch - Minimal / (R) Rear Door, Molding - Scratch - Minimal / (R) Front Door, Molding - Scratch - Minimal / (R) Step, In-panel, Side Spoiler - Scratch - Minimal / Trunk Hood, Rear Gate - Scratch - Minimal / (L) Front Door, Molding - Scratch - Minimal / (L) Rear Door, Molding - Scratch - Minimal / Front Bumper, Grille, Lamps - Scratch - Minimal / Bonnet, Headlight - Scratch - Minimal / Roof - Scratch - Minimal / (L) Rear Fender, Molding - Modified - Small |
