## General Information

| Make | Toyota | Model | Vios |
| Registration No. | DBS4583 | Chassis No. | PA1B18F33R4277984 |

## Body / Panel Condition

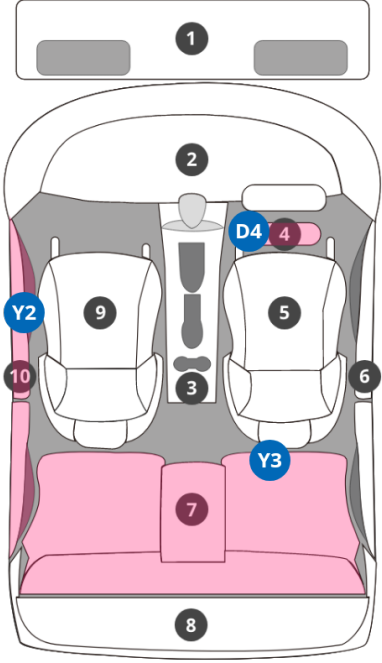
| Interior Evaluation : <b>C</b> | Exterior Evaluation : <b>B</b> |
| <p><b>Remarks</b><br/>Rear Seat - Grime - Medium / Carpet - Worked - Large / (L) Front Trim - Grime - Small</p> | <p><b>Remarks</b><br/>(R) Rear Fender, Molding - Scratch &amp; Dent - Small / Trunk Hood, Rear Gate - Crack, Gap - Small / (L) Rear Wheel, Cover - Scratch, Corrosion - Small / (L) Front Wheel, Cover - Scratch, Corrosion - Small / (R) Rear Wheel, Cover - Scratch, Corrosion - Small / (R) Front Wheel, Cover - Scratch, Corrosion - Small / Roof - Dent - Small / Front Bumper, Grille, Lamps - Scratch - Medium</p> |
