## General Information

| Make | Toyota | Model | Vios |
| Registration No. | CCQ7369 | Chassis No. | PA1B18F34S4302722 |

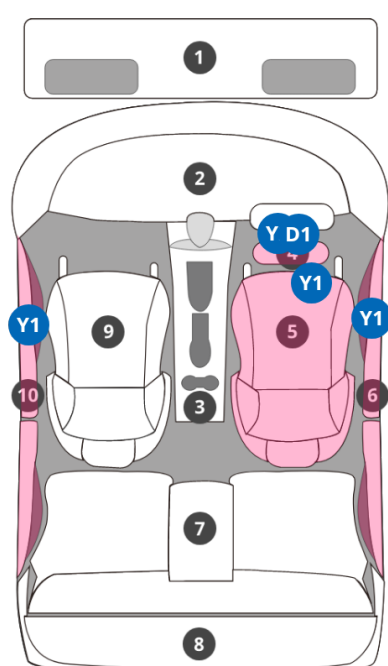
| <div> </div> <div> <div>a : Cut, Fray d : Loose, Deformed k : Animal Hair s : Smell t : Cigarette Burns x : Defective y : Stain</div> </div> | <div> </div> <div> <div>A : Scratch AU : Scratch &amp; Dent B : Modified C : Corrosion G : Stone chip P : Faded S : Rust SC : Rust &amp; Corrosion U : Dent X : Defective Y : Crack, Gap</div> </div> |
| <div> <div>Remarks</div> <div>(R) Front Trim - Grime - Minimal / (R) Front Seat - Grime - Minimal / (L) Front Floor Mat - Grime - Small / Carpet - Worked - Minimal / (L) Front Trim - Grime - Minimal</div> </div> | <div> <div>Remarks</div> <div>(R) Front Fender, Molding - Scratch &amp; Dent - Large / (R) Front Door, Molding - Scratch &amp; Dent - Large / (R) Mirror - Crack - Damaged / (R) Mirror - Scratch - Minimal / (R) Step, In-panel, Side Spoiler - Scratch - Minimal / (R) Rear Door, Molding - Scratch - Minimal / (R) Rear Fender, Molding - Scratch - Minimal / Rear Bumper, Lamps, Panels - Scratch - Large / Trunk Hood, Rear Gate - Scratch - Minimal / (L) Rear Fender, Molding - Scratch - Minimal / (L) Rear Door, Molding - Scratch - Minimal / (L) Front Door, Molding - Scratch - Minimal / (L) Step, In-panel, Side Spoiler - Scratch - Minimal / (L) Mirror - Scratch - Minimal / (L) Front Fender, Molding - Scratch - Minimal / Member (Bolted) - Dent - Yes / Front Bumper, Grille, Lamps - Crack, Gap - Large / Bonnet, Headlight - Scratch &amp; Dent - Medium</div> </div> |

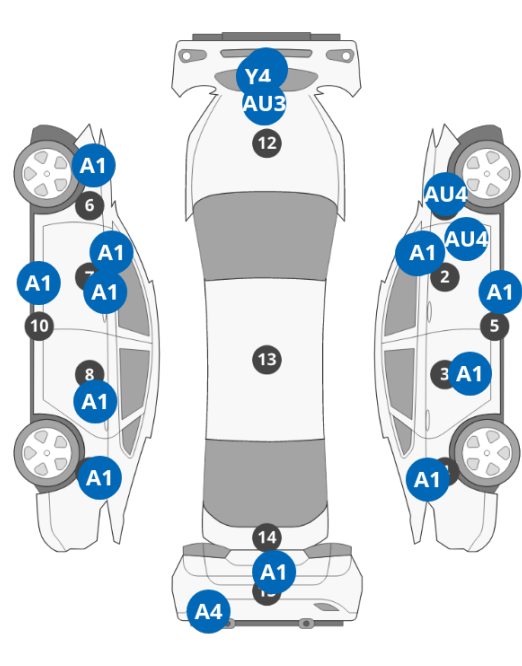
With Lto plate, with warranty booklet and jack, 1key, no spare tire and tools, scratches on headlights and taillights, r side mirror issue ,
