## General Information

| Make | Toyota | Model | Hilux Tamaraw |

## Body / Panel Condition

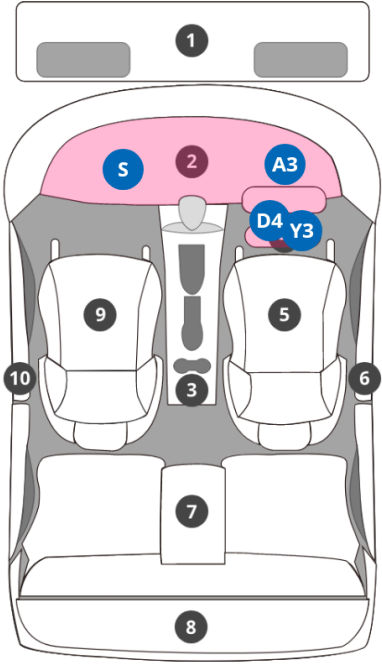
| Interior Evaluation : <b>C</b> | Exterior Evaluation : <b>E</b> |
| <p><b>Remarks</b><br/>Dashboard - Worn, Scratch, Cut, Crack - Medium / (R)<br/>Front Floor Mat - Grime - Medium / (L) Front Floor Mat - Worked - Large / Overall Interior - Smell - Yes</p> | <p><b>Remarks</b><br/>Front Bumper, Grille, Lamps - Scratch - Large / (L) Side Gate - Scratch &amp; Dent - Large / Rear Bumper, Lamps, Panels - Scratch - Large / Cargo Bed Floor - Scratch &amp; Dent - Large / (R) Side Gate - Scratch &amp; Dent - Large / Roof - Scratch - Large / (R) Front Door, Molding - Scratch - Minimal / (R) Front Fender, Molding - Scratch - Minimal / (L) Front Door, Molding - Scratch - Minimal / Bonnet, Headlight - Scratch - Minimal</p> |
