## General Information

| Make | Toyota | Model | Hilux Tamaraw |
| Registration No. | CCQ5175 | Chassis No. | PAHACACA7S6426442 |

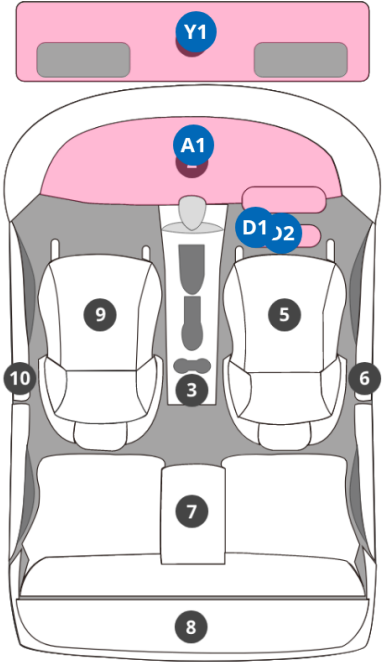
| Interior Evaluation : <span style="color: red; font-weight: bold;">A</span> | Exterior Evaluation : <span style="color: red; font-weight: bold;">E</span> |
|---|---|
| <b>Remarks</b><br>Dashboard - Worn, Scratch, Cut, Crack - Minimal /<br>Ceiling - Grime - Minimal / (L) Front Floor Mat - Worked<br>- Small / Carpet - Worked - Minimal | <b>Remarks</b><br>(R) Front Fender, Molding - Scratch - Minimal / (R) Mirror - Scratch - Minimal / (R) Front Door, Molding - Scratch - Small / (R) Step, In-panel, Side Spoiler - Scratch - Minimal / (R) Side Gate - Scratch - Small / Roof - Modified - Large / Rear Gate - Modified - Large / Rear Bumper, Lamps, Panels - Scratch - Medium / (L) Side Gate - Scratch - Small / (L) Step, In-panel, Side Spoiler - Scratch - Minimal / (L) Front Door, Molding - Scratch - Minimal / (L) Mirror - Scratch - Minimal / (L) Front Fender, Molding - Scratch - Minimal / Front Bumper, Grille, Lamps - Crack, Gap - Large / Cargo Bed Floor - Scratch - Large / Cab Back Panel - Modified - Large / Bonnet, Headlight - Scratch - Minimal |

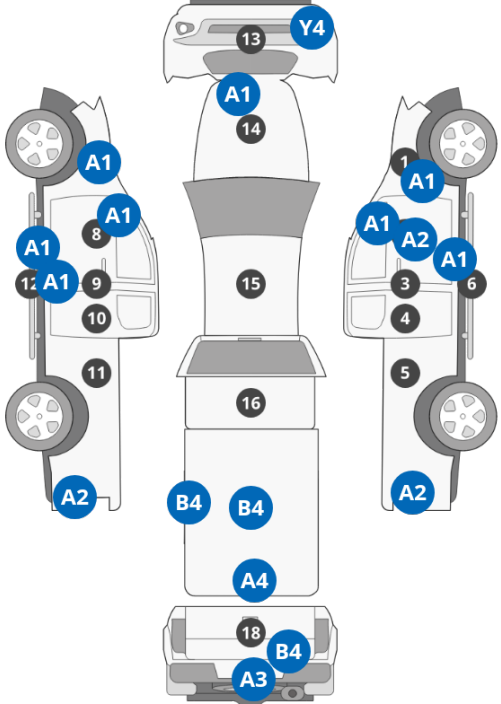
No Lto plate, 1key, no warranty booklet and tools, no spare tire and jack, scratches on headlights, slippery cab bed floor
