## General Information

| Make | Toyota | Model | Vios |

## Body / Panel Condition

## Overall Evaluation :

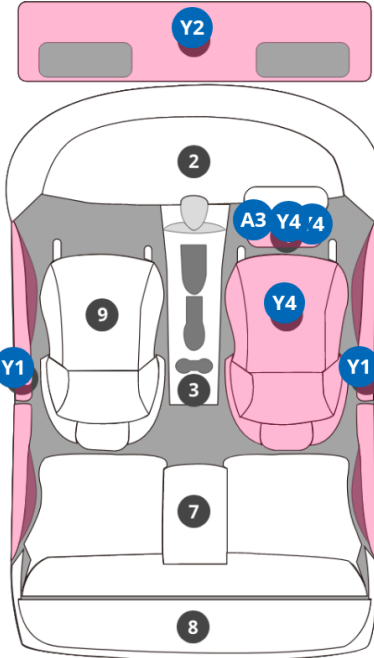
| Interior Evaluation : <span style="color: red; font-weight: bold;">C</span> | Exterior Evaluation : <span style="color: red; font-weight: bold;">E</span> |
| <p><b>Remarks</b></p> <p>Ceiling - Grime - Small / (R) Front Trim - Grime - Minimal / (R) Front Floor Mat - Grime - Large / (R) Front Seat - Grime - Large / Mat Other - Grime - Large / (L) Front Trim - Grime - Minimal / (L) Front Floor Mat - Cut, Crack - Medium</p> | <p><b>Remarks</b></p> <p>(L) Front Fender, Molding - Scratch - Medium / Bonnet, Headlight - Scratch - Small / Front Bumper, Grille, Lamps - Scratch - Medium / (R) Front Fender, Molding - Scratch - Medium / (R) Front Door, Molding - Scratch - Large / (R) Rear Door, Molding - Scratch &amp; Dent - Medium / (R) Step, In-panel, Side Spoiler - Scratch &amp; Dent - Medium / (R) Rear Fender, Molding - Scratch - Large / Rear Bumper, Lamps, Panels - Scratch - Small / (L) Rear Fender, Molding - Scratch - Large / (L) Rear Door, Molding - Scratch - Small / (L) Front Door, Molding - Scratch - Medium / (L) Mirror - Scratch - Minimal / (R) Mirror - Scratch - Minimal / Roof - Scratch - Small</p> |

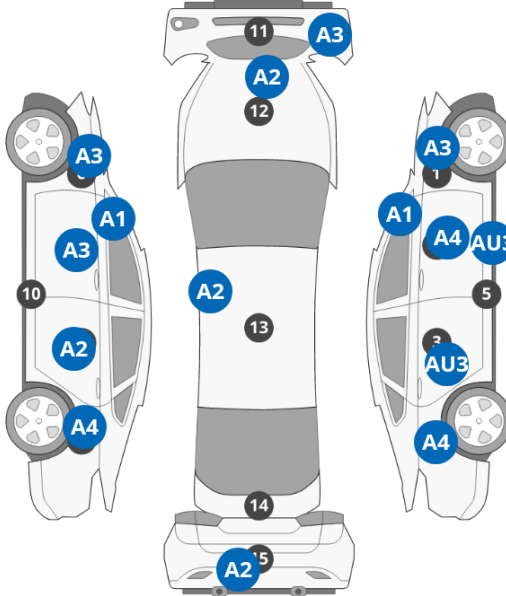
Steering issue. Battery light on. Hairline scratches and swirlmarks around the exterior. Foul smell. Without warranty booklet, spare tire and tools. With jack and seat cover. 2 keys. With LTO plate.
