## General Information

Date & Time: 23, May, 2026 16:40

| Make | Toyota | Model | Avanza |

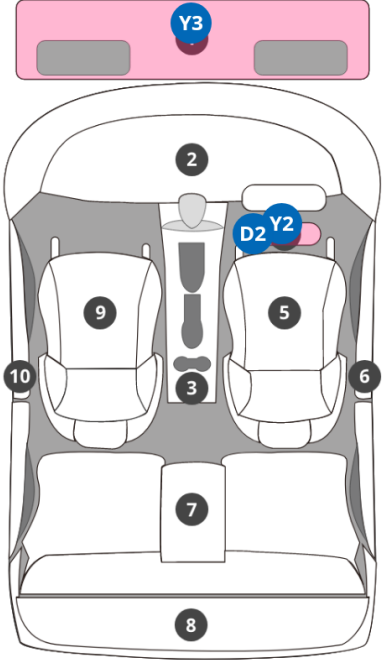
| Interior Evaluation : <b>B</b> | Exterior Evaluation : <b>E</b> |
|---|---|
| <p><b>Remarks</b><br/>Ceiling - Grime - Medium / Mat Other - Grime - Small / (L) Front Floor Mat - Worked - Small</p> | <p><b>Remarks</b><br/>(L) Rear Door - Repair Traces - Yes / (L) Rear Fender - Repair Traces - Yes / (L) Front Fender, Molding - Scratch - Minimal / (L) Mirror - Scratch - Small / (L) Front Door, Molding - Scratch - Small / (L) Rear Door, Molding - Scratch - Medium / (L) Rear Fender, Molding - Scratch - Medium / Rear Bumper, Lamps, Panels - Scratch - Large / Trunk Hood, Rear Gate - Scratch - Minimal / (R) Rear Fender, Molding - Scratch - Large / (R) Front Door, Molding - Scratch &amp; Dent - Large / (R) Step, In-panel, Side Spoiler - Scratch &amp; Dent - Large / (R) Mirror - Scratch - Small / (R) Front Fender, Molding - Scratch - Small / Bonnet, Headlight - Scratch &amp; Dent - Small / Member (Bolted) - Dent - Yes / Front Bumper, Grille, Lamps - Scratch &amp; Dent - Large / (R) Rear Door, Molding - Scratch &amp; Dent - Small</p> |
